AMORY ENGINEERS, P.C.

Subject: Duxbury Beach Seawall Assessment and Replacement Phasing Plan

Duxbury Beach Seawalls - 2020 Condition Assessment

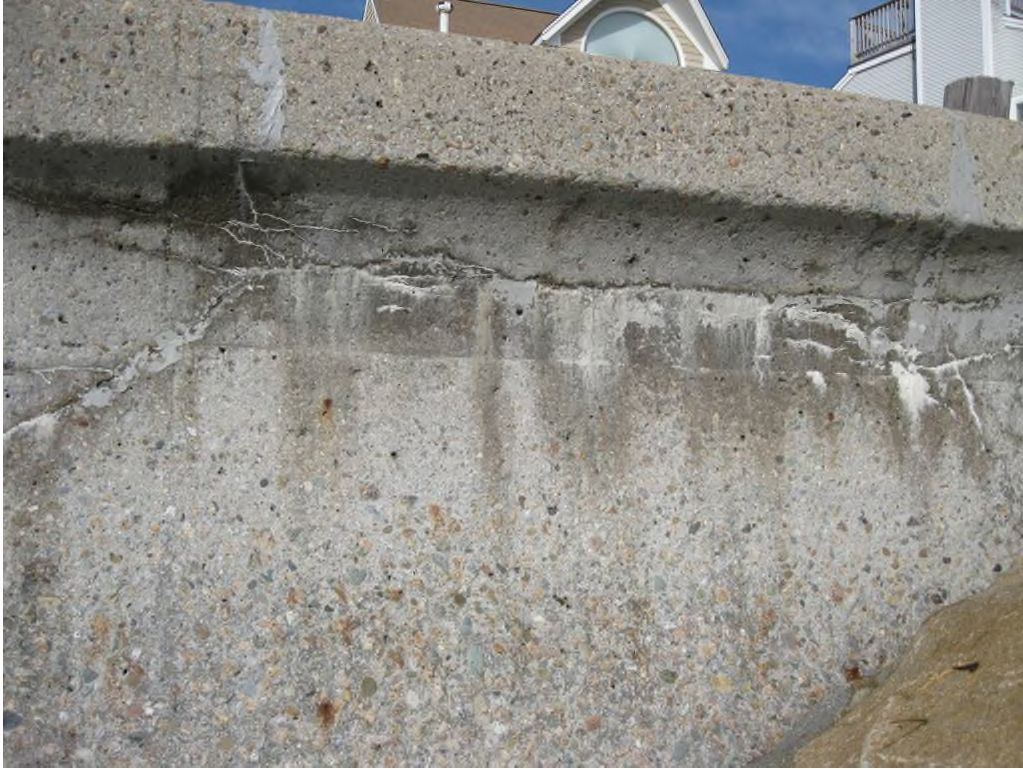
Close up of cracks in Section 8

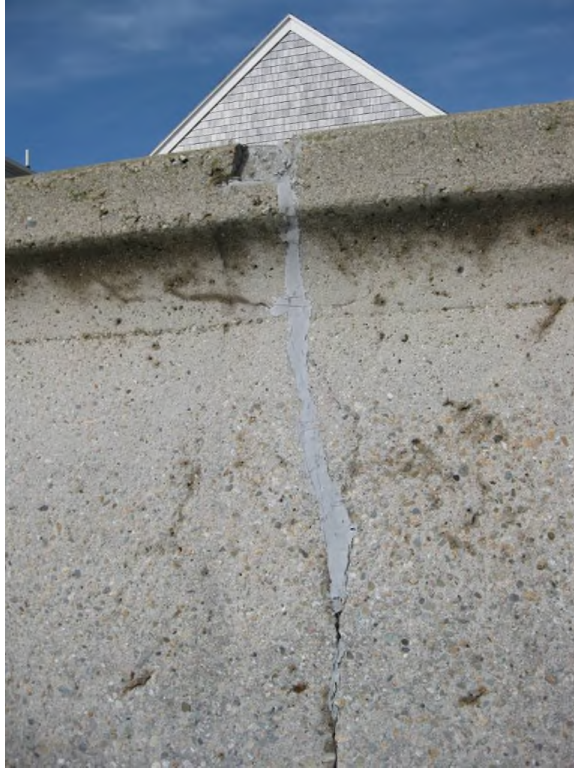
Crack in Section 12

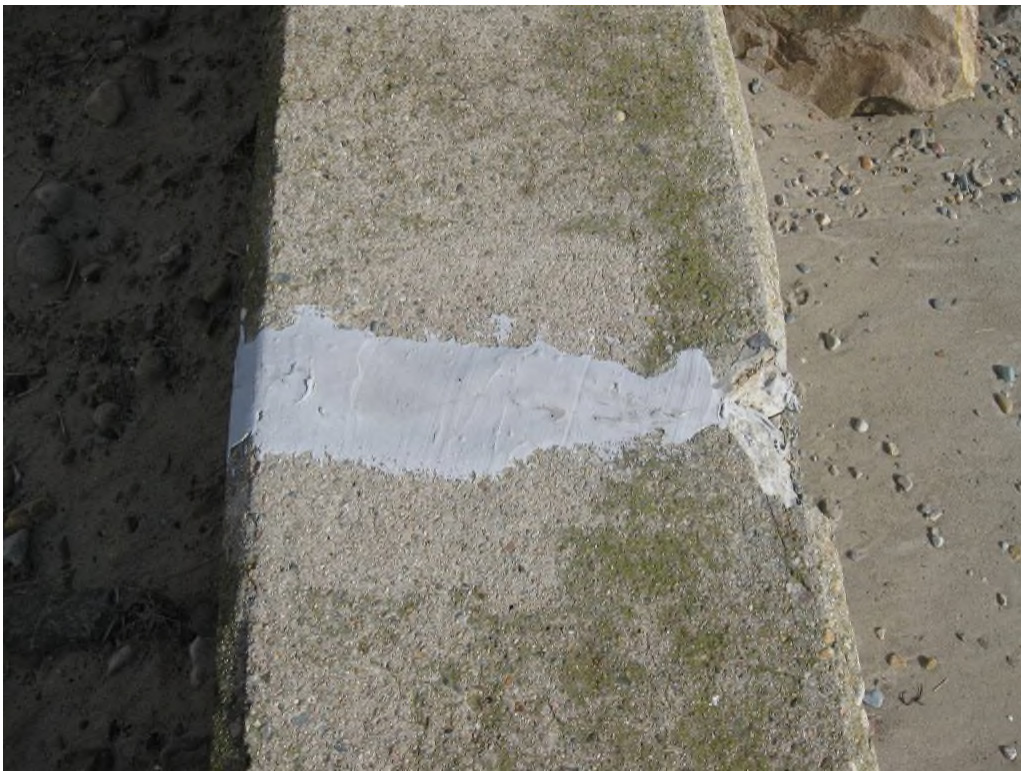
Top of crack in Section 12

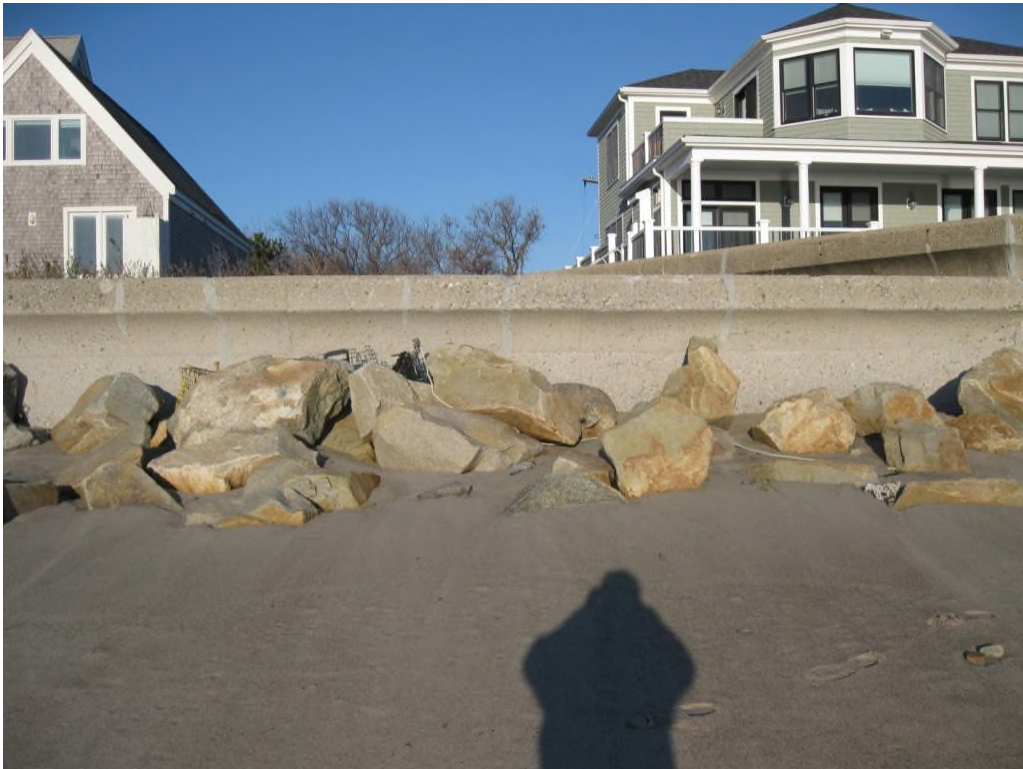
Section Number	Condition Description	Condition Rating
21	To be replaced under Phase I	
22	To be replaced under Phase I	
23	To be replaced under Phase I	
24	To be replaced under Phase I	
25	To be replaced under Phase I	
26	To be replaced under Phase I	
27	To be replaced under Phase I	
28	To be replaced under Phase I	
29	To be replaced under Phase I	
30	To be replaced under Phase I	
31	To be replaced under Phase I	
32	Intermediate vertical cracks, minor horizontal cracks and efflorescence	4

Priority 3: Replace Section 32 of the south low wall and the leaning sections (Sections 33-40) of the south high wall. Total length is approximately 425 l.f. The leaning sections of wall are rated lower than the sections recommended under Priority 2 but the leaning sections have revetment in front which adds some stability to these sections and make them slightly less susceptible to storm damage than the sections of south low wall without revetment.

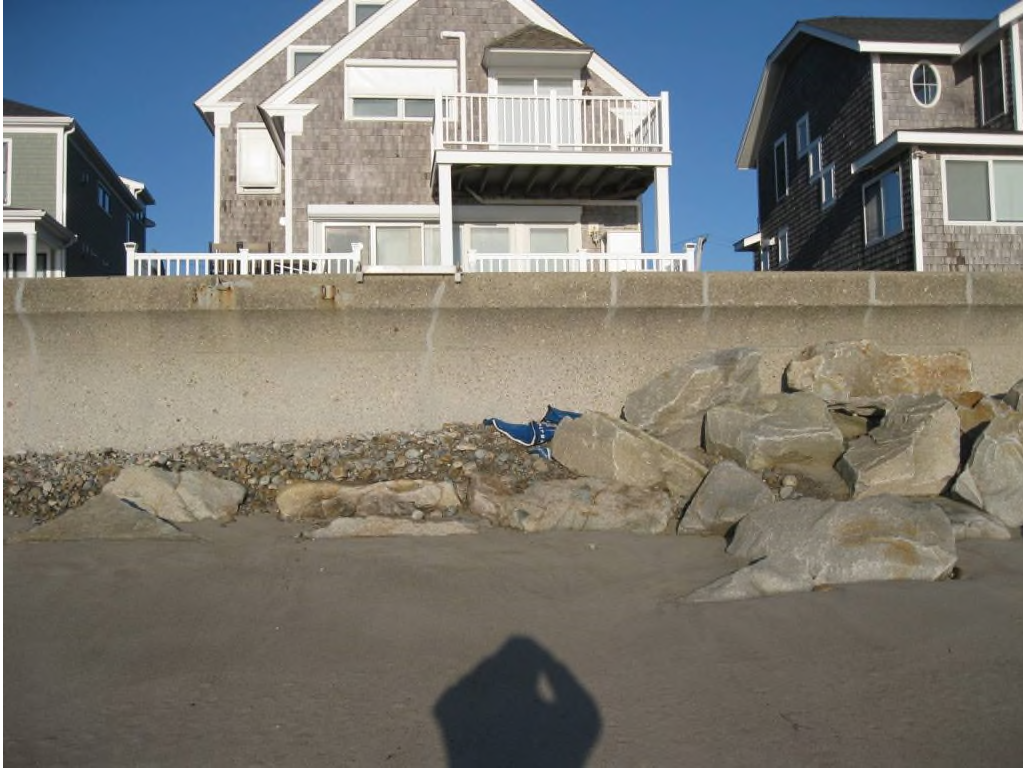
Section 34

33	Minor horizontal and vertical cracks and efflorescence, a couple of intermediate vertical cracks	6
34	Movement seaward at joint with 33; intermediate vertical cracks throughout, major crack & spalling at joint with 35	4
35	Significant seaward movement at joint with 34; section leaning seaward; revetment in front; major crack & spalling at joint with 36	3
36	Section leaning seaward; revetment in front; minor horizontal and vertical cracks and efflorescence	4
37	Section leaning seaward; revetment in front; minor horizontal and vertical cracks and efflorescence	4
38	Section leaning seaward; revetment in front; intermediate and major vertical cracks and efflorescence	3
39	Section leaning seaward; revetment in front; minor horizontal and vertical cracks and efflorescence	4
40	Section leaning seaward; revetment in front; intermediate and major vertical cracks and efflorescence, major movement at joint with 41	4

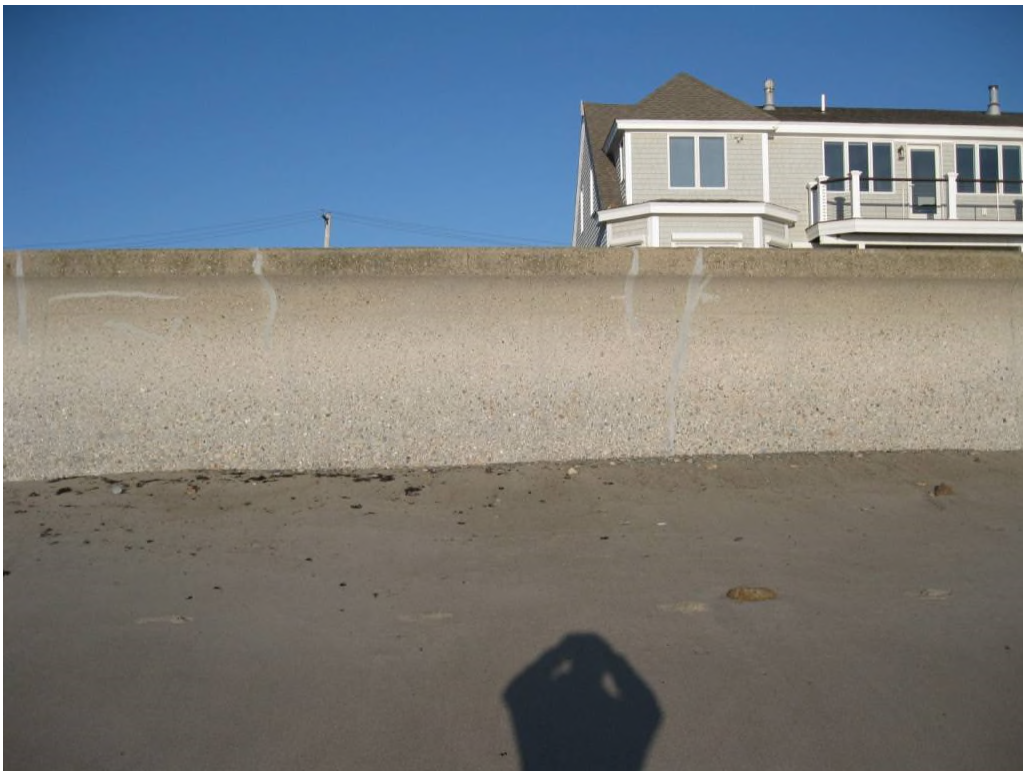
Section 41

Section Number	Condition Description	Condition Rating
41	Minor horizontal and vertical cracks and efflorescence, intermediate vertical crack about mid-point	4
42	Minor & intermediate horizontal and vertical cracks and efflorescence	6
43	Minor horizontal and vertical cracks and efflorescence	7
44	Minor & intermediate horizontal and vertical cracks and efflorescence	6
45	Minor horizontal and vertical cracks and efflorescence	7
46	Minor & intermediate horizontal and vertical cracks and efflorescence	6
47	Minor & intermediate horizontal and vertical cracks and efflorescence	6
48	Minor horizontal and vertical cracks and efflorescence	7
49	Minor horizontal and vertical cracks and efflorescence	7
50	Minor & intermediate horizontal and vertical cracks and efflorescence	6
51	Minor & intermediate horizontal and vertical cracks and efflorescence	6
52	Minor & intermediate horizontal and vertical cracks and efflorescence	5

Priority 4: Replace the remainder of the south high wall (Sections 41-58). Total length is approximately 1,010 l.f.
