Duxbury Seawalls **Condition Survey and Study** *Duxbury, MA*

Project No. P10-2606-G2, (3779-G)

July 2012

Prepared By:
Bourne Consulting Engineering
3 Bent Street
Franklin, MA 02038

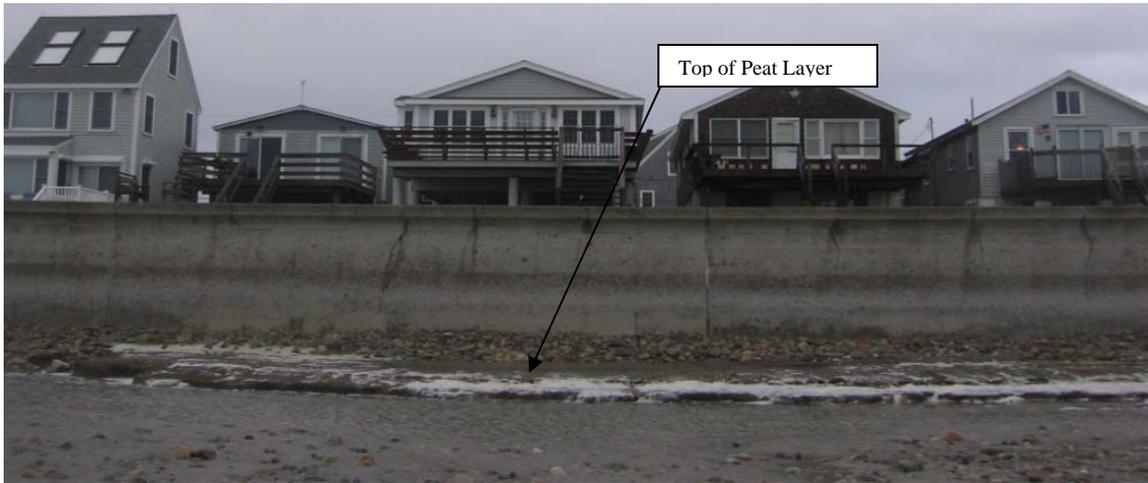
Peat layer was visible on the beach while it was in an eroded condition in November 2010 between STA 107+00 and 109+00 along the South Low Wall. Typical photograph is shown below.

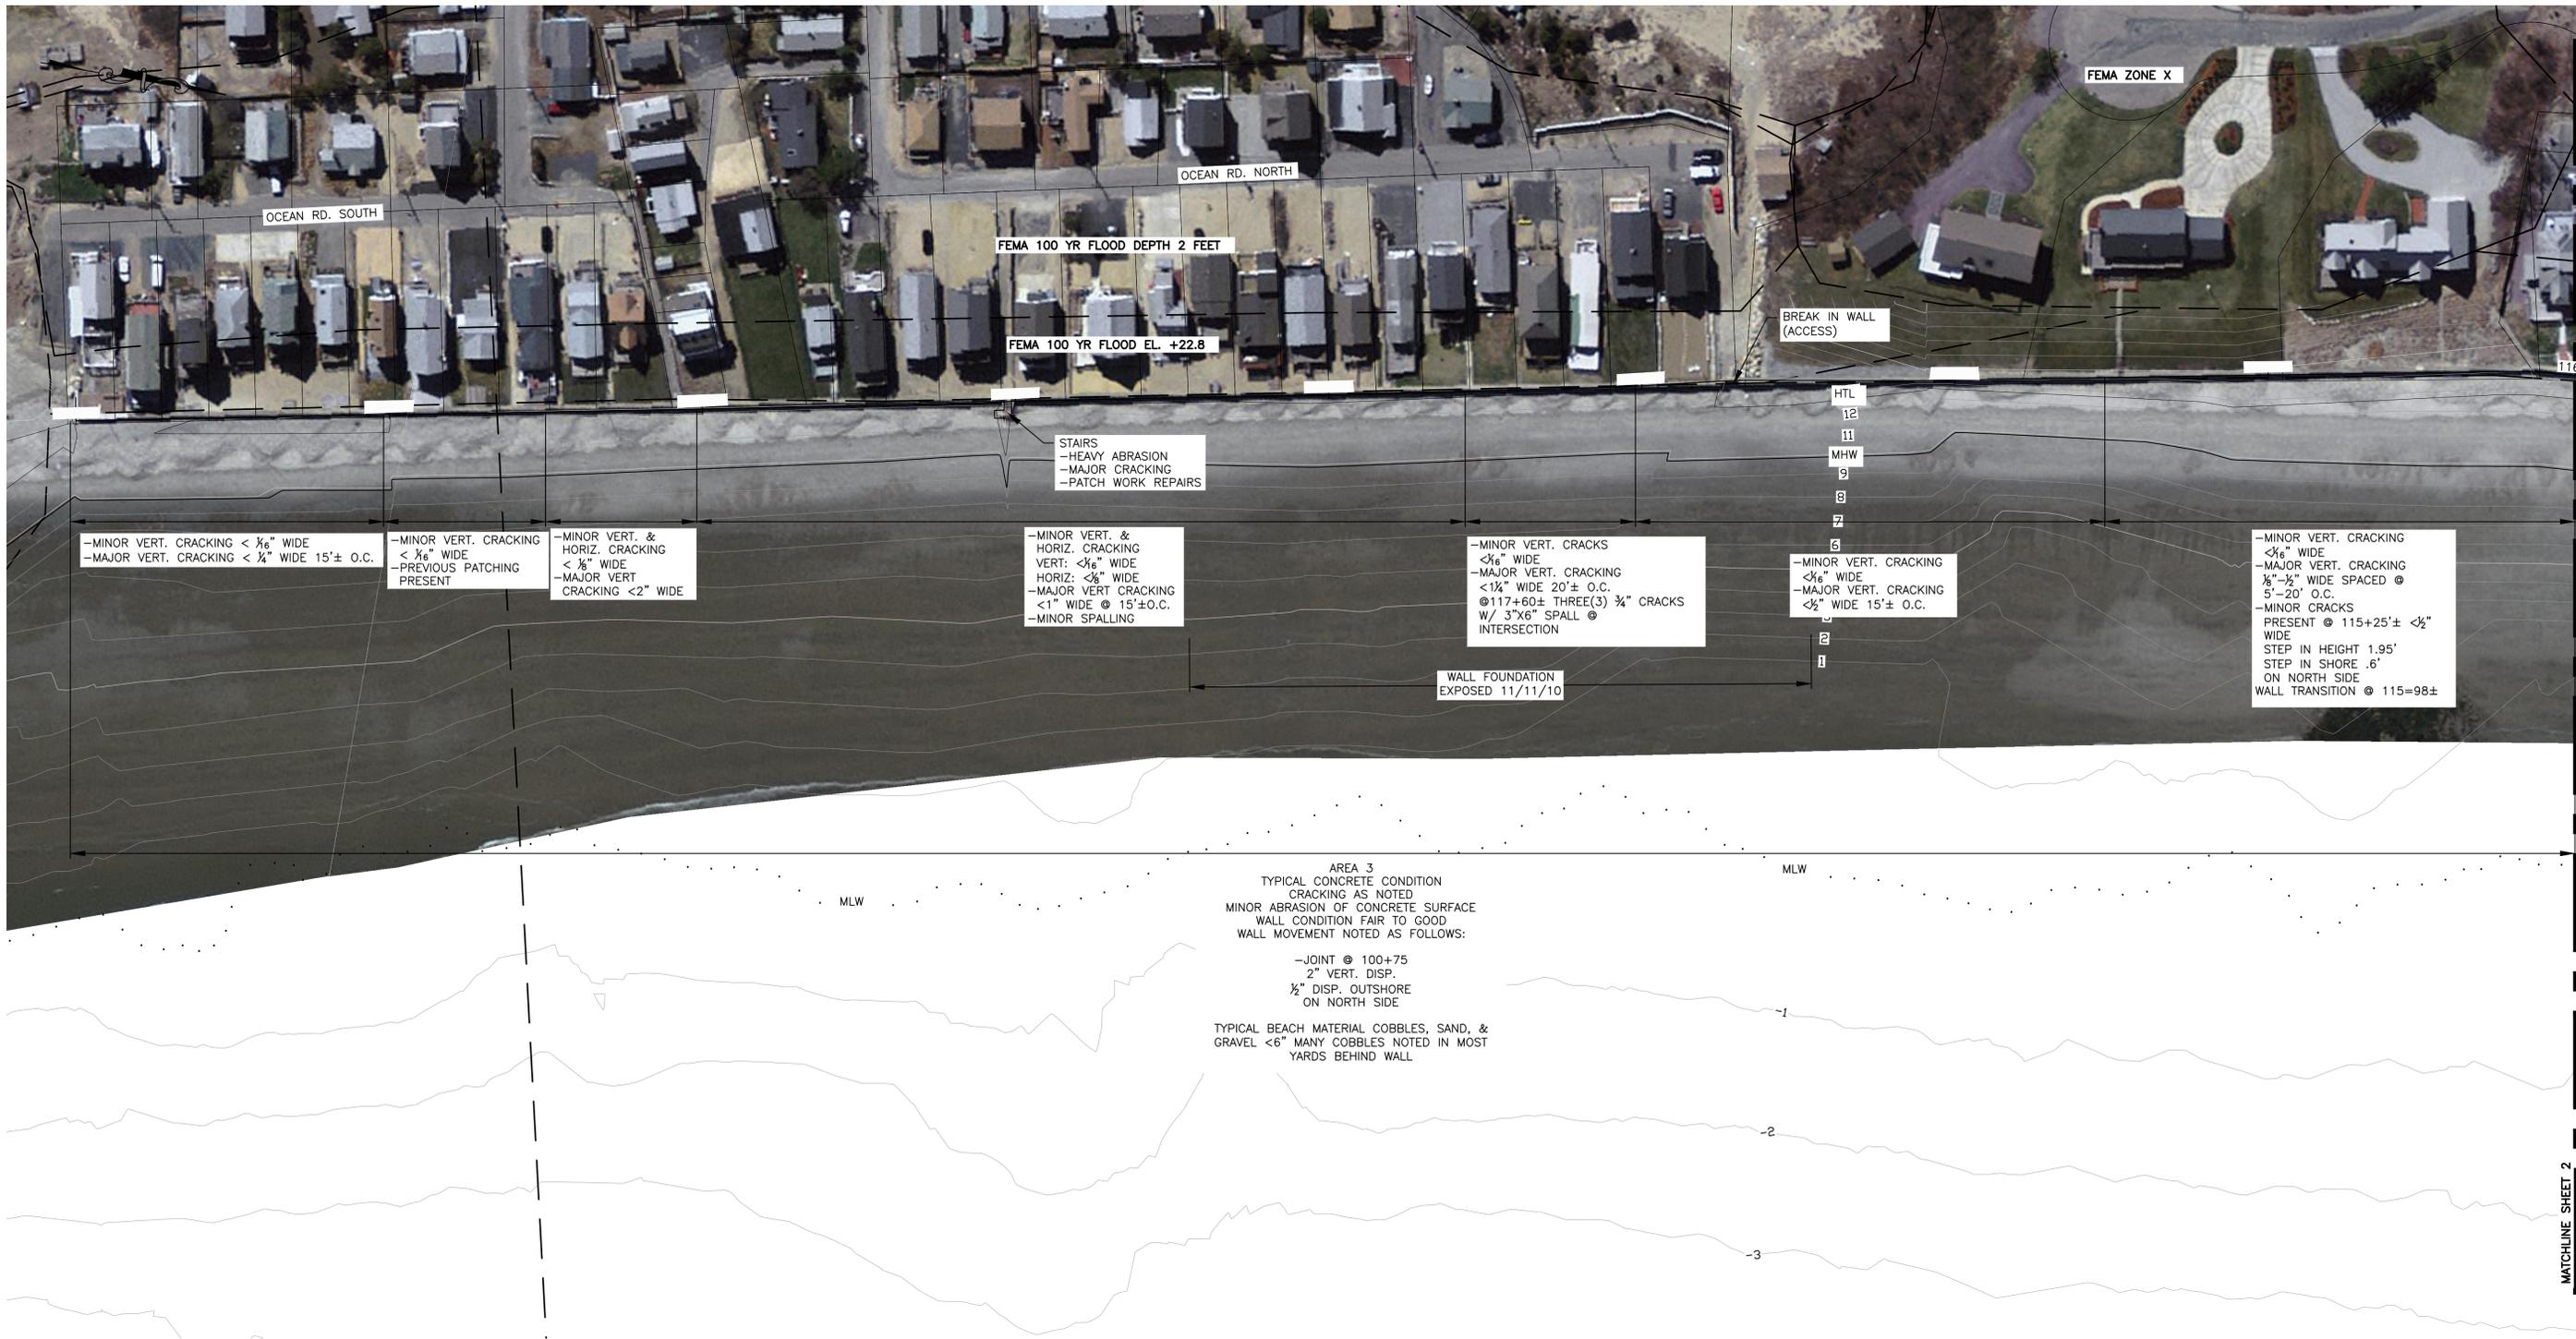
-MINOR VERT. CRACKING $\lt; \frac{1}{8}$ WIDE
 -MAJOR VERT. CRACKING $\lt; \frac{1}{4}$ WIDE 15'± O.C.

-MINOR VERT. CRACKING $\lt; \frac{1}{8}$ WIDE
 -PREVIOUS PATCHING PRESENT

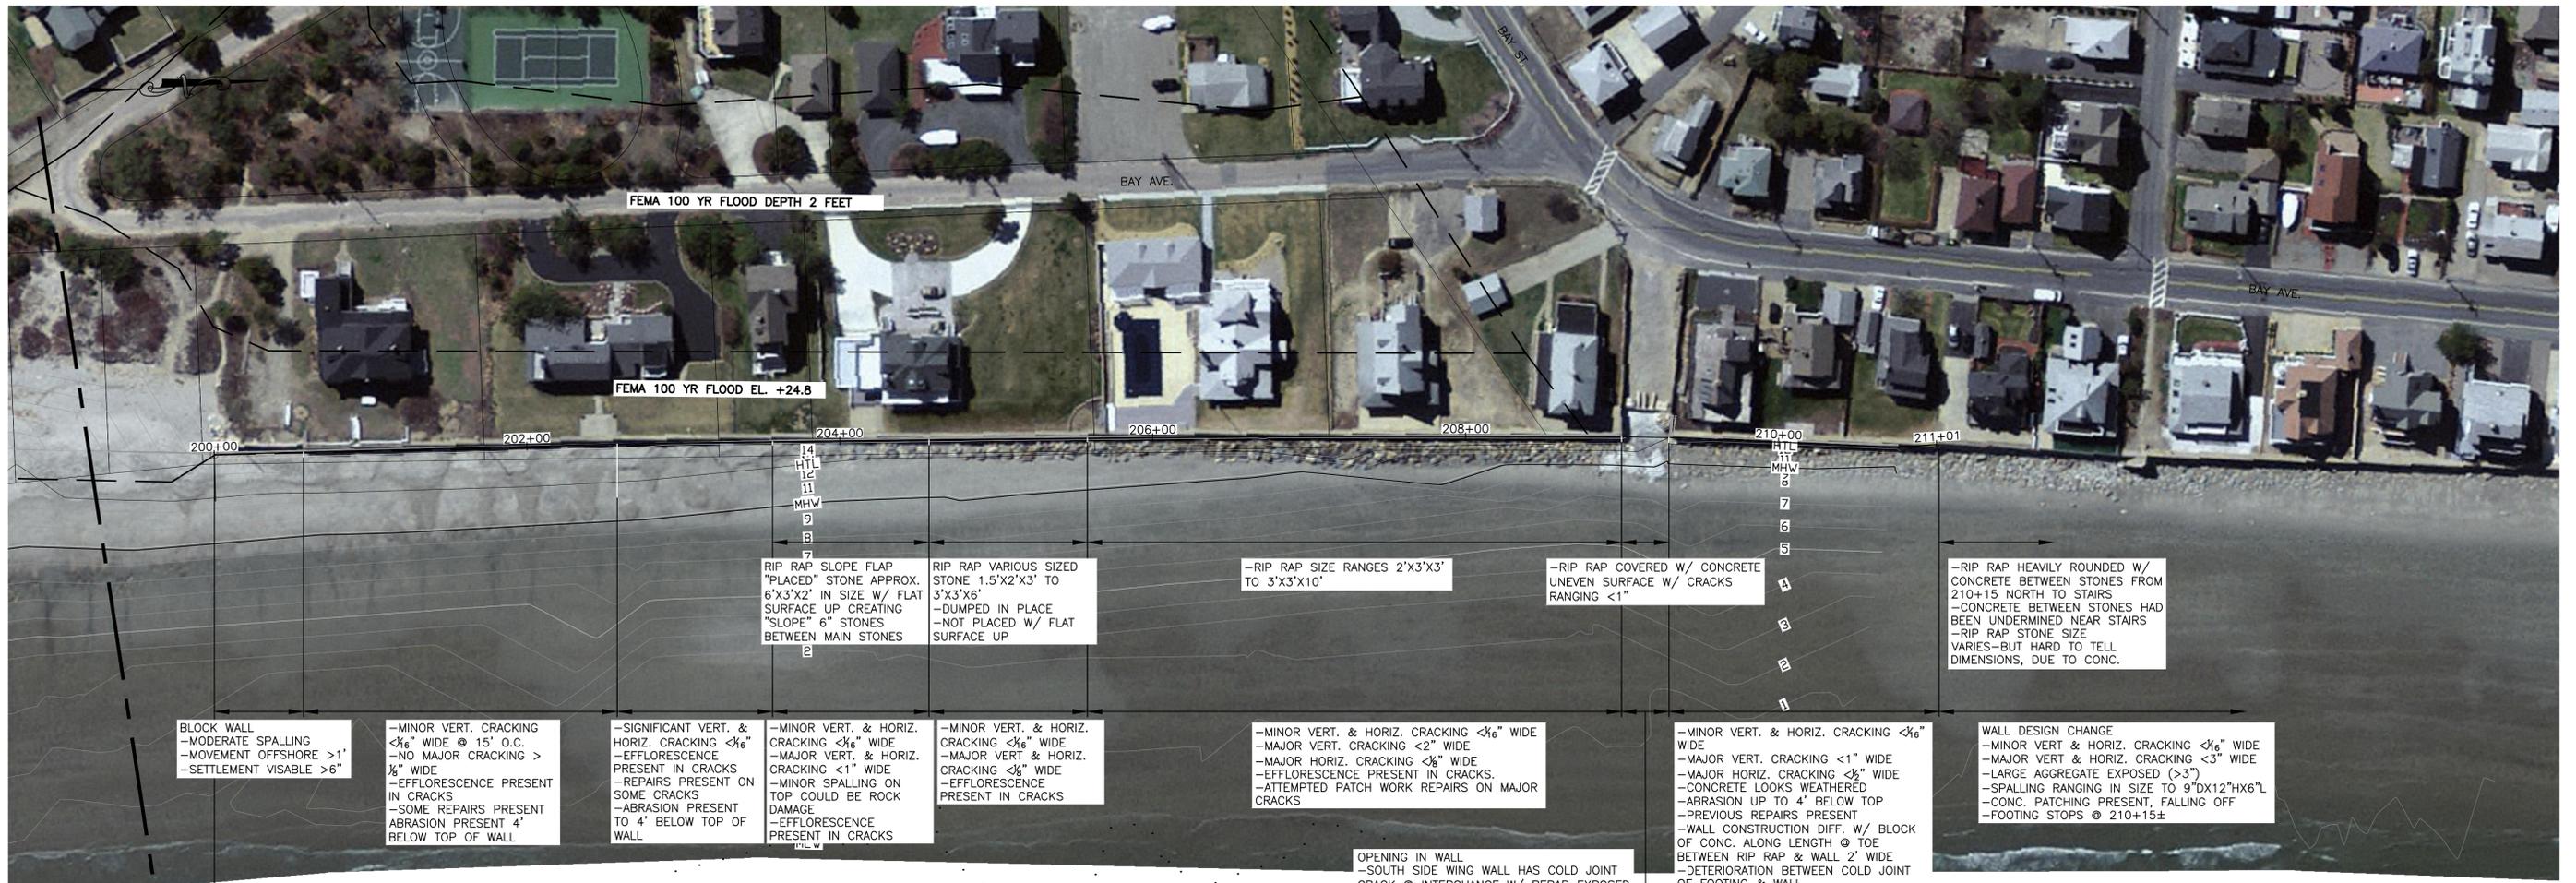
AREA 4B
 TYPICAL CONCRETE CONDITION
 CRACKING AS NOTED
 MINOR ABRASION OF CONCRETE SURFACE
 WALL CONDITION FAIR TO GOOD
 WALL MOVEMENT AS FOLLOWS:
 -JOINT @ 203+50± 3" SHIFT OUTSHORE ON N. SIDE
 -JOINT @ 205+02± 6" SHIFT INSHORE ON N. SIDE
 -@ 206+75± <1" MOVEMENT VERT. & HORIZ.
 -JOINT @ 209+01± 3" SHIFT N. SIDE OUTSHORE
 SOME COBBLES NOTED IN YARDS BEHIND WALL
 BEACH MATERIAL COBBLES <6" SAND AND GRAVEL

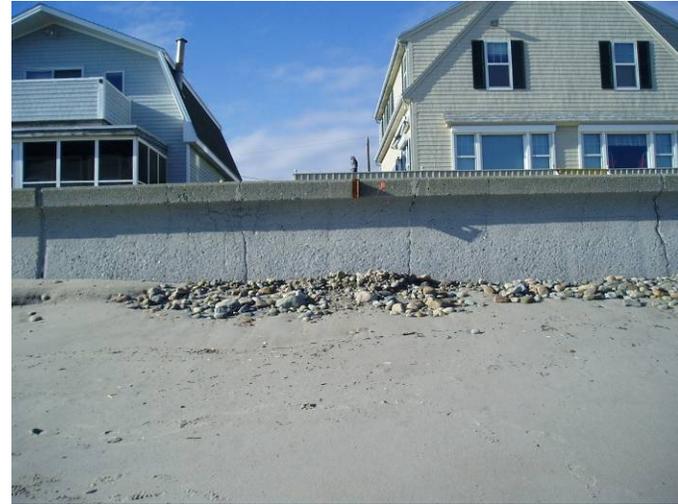
PHOTOGRAPH 3 - TYPICAL MAJOR VERT. CRACKING IN SOUTH WALL APPROX 106+50

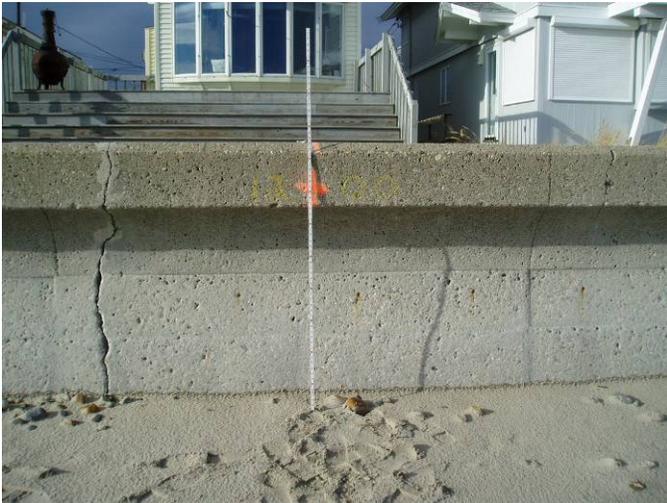
PHOTOGRAPH 2 - SOUTH WALL STA 102+00 - TYP MAJOR CRACKING

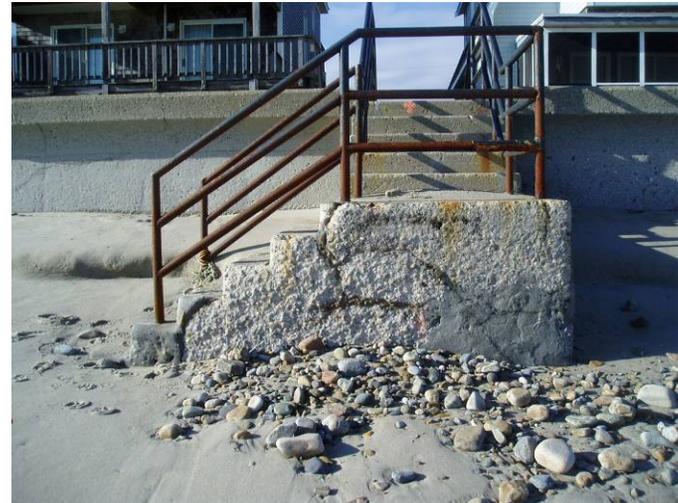
- Stairs at STA 106+00
 - Had scaling and damage due to debris and stones abrading the concrete
 - Concrete had been patched previously but patch was failing

PHOTOGRAPH 4 - ABRASION, CRACKING AND PATCHING ON STAIRS AT 106+00

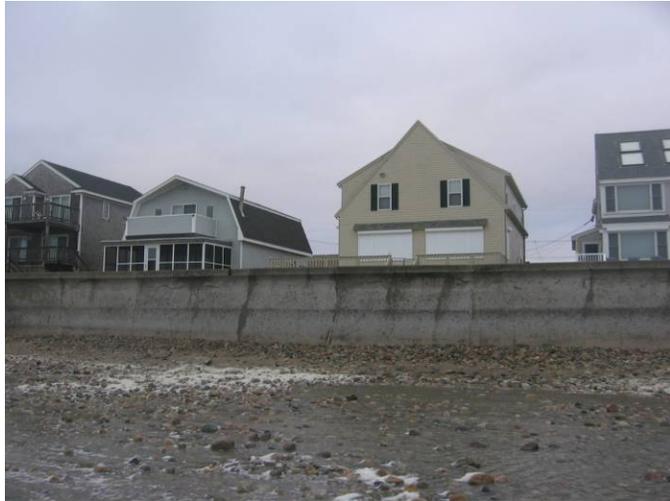
PHOTOGRAPH 5 - TYP CRACKS IN SOUTHERN WALL ~15' OC

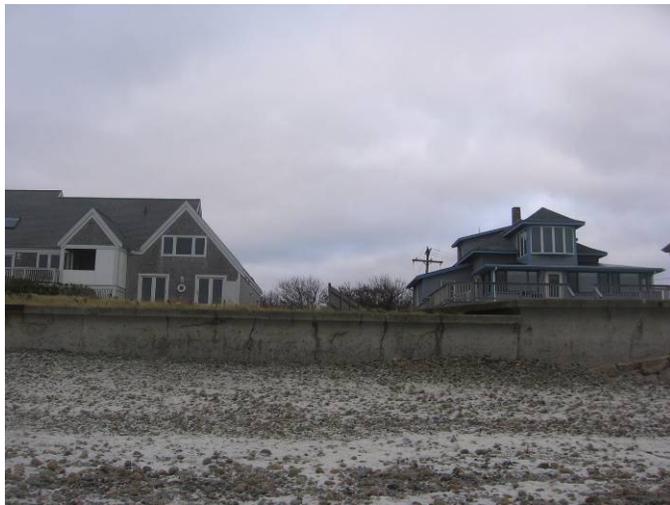
PHOTOGRAPH 6 - CRACKING ON NORTH END OF SOUTH WALL
STEP IN WALL HEIGHT 1.95'

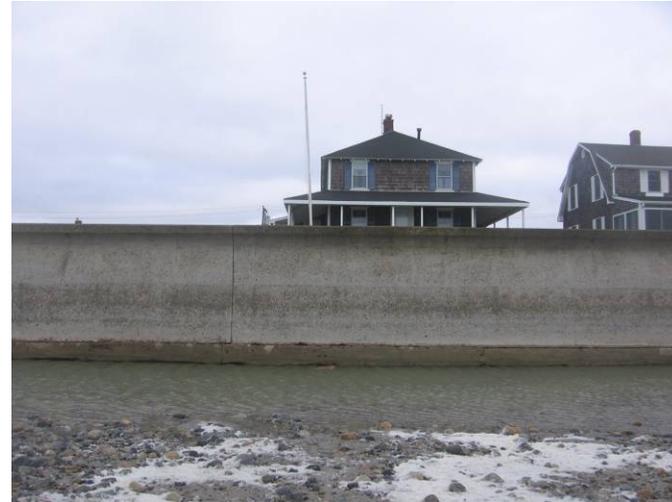
PHOTOGRAPH 19 - UNDERMINING FOUND ON 11/11/10 STA 122+00

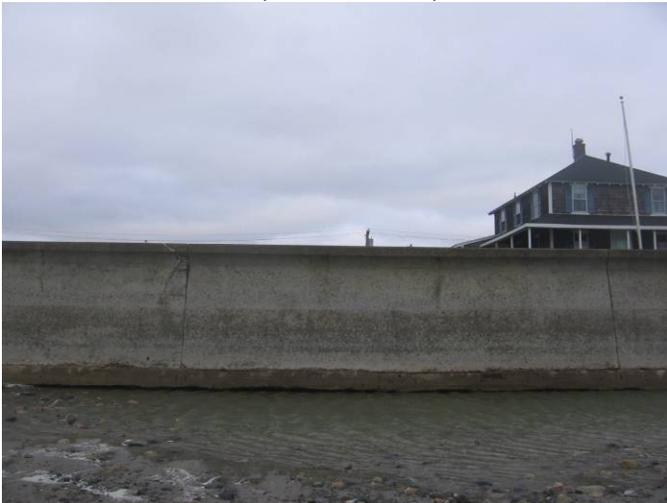
PHOTOGRAPH 18 - UNDERMINING FOUND ON 11/11/10 STA 122+00

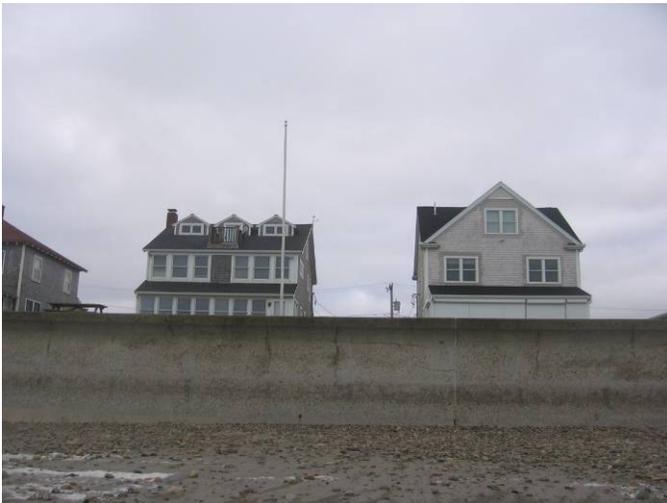
PHOTOGRAPH 22 - TYP. CRACKING IN WALL STA 125+00

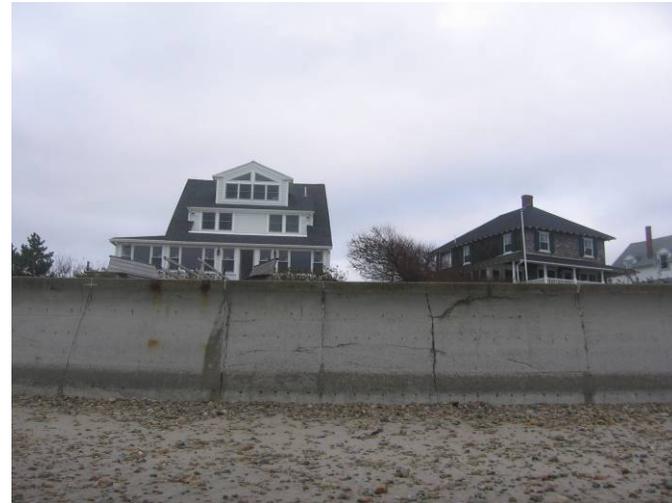
PHOTOGRAPH 24 - RUST STAINING

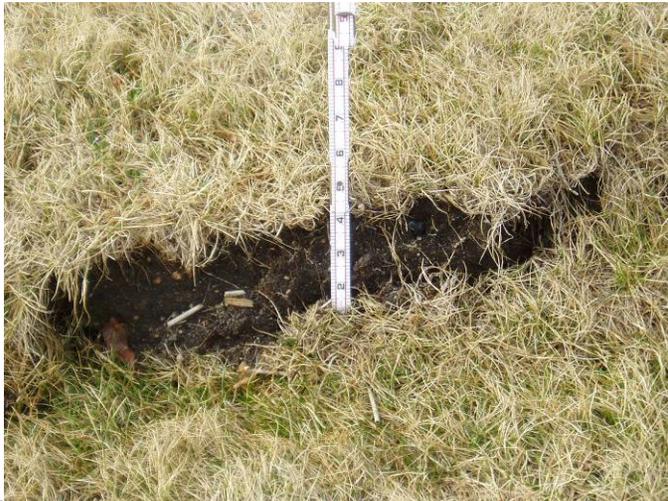
PHOTOGRAPH 26 - CRACKING IN GROUND SURFACE INDICATING WALL MOVEMENT AT UNDERMINED AREA

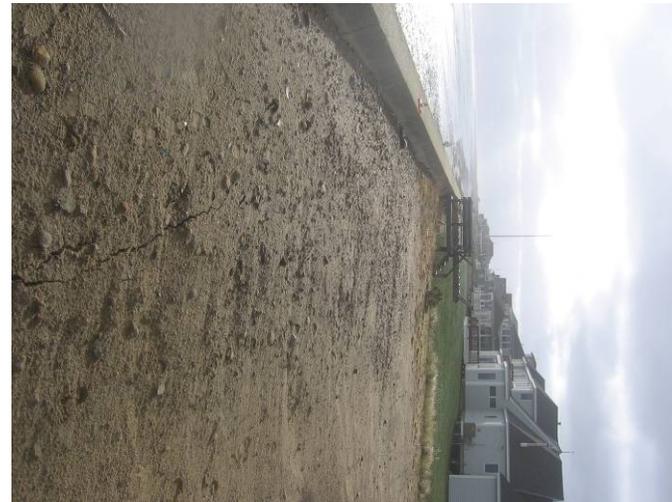
PHOTOGRAPH 28 - CRACK IN GROUND BEHIND UNDERMINED AREA

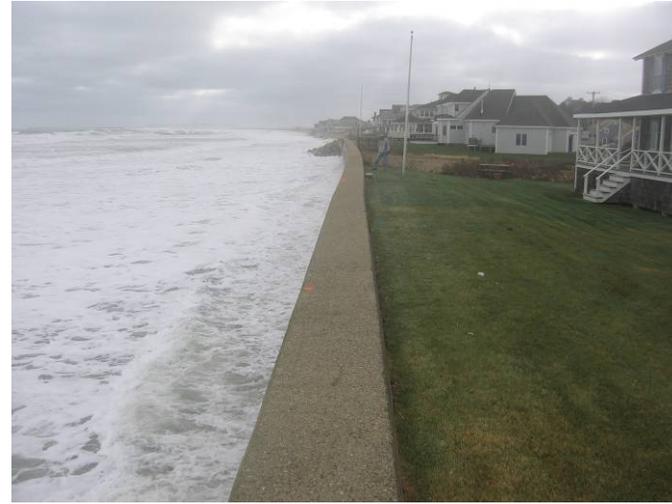
PHOTOGRAPH 31 - CRACK AT END OF LEVEL AREA STA 123+00

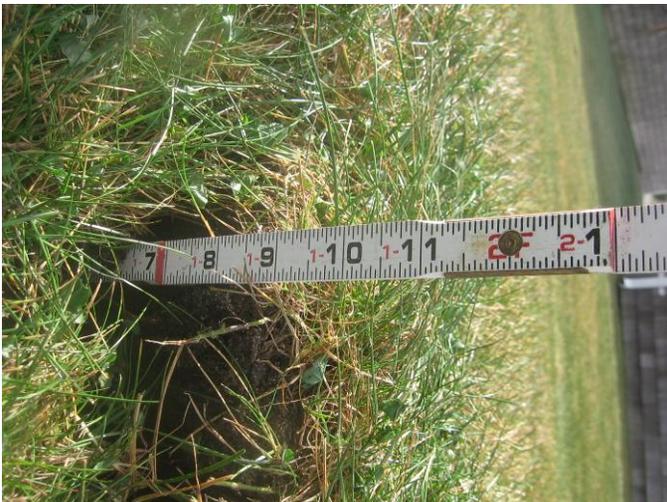
PHOTOGRAPH 30 - SETTLEMENT AND CRACKING OF GROUND BEHIND

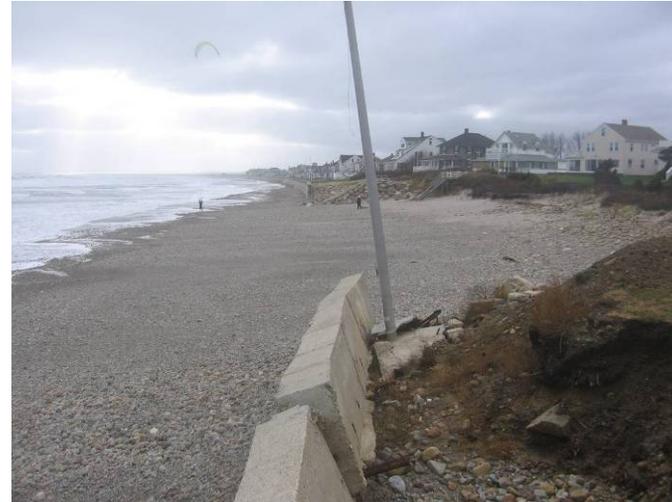
PHOTOGRAPH 35 - FAILURE OUTWARD ROTATION

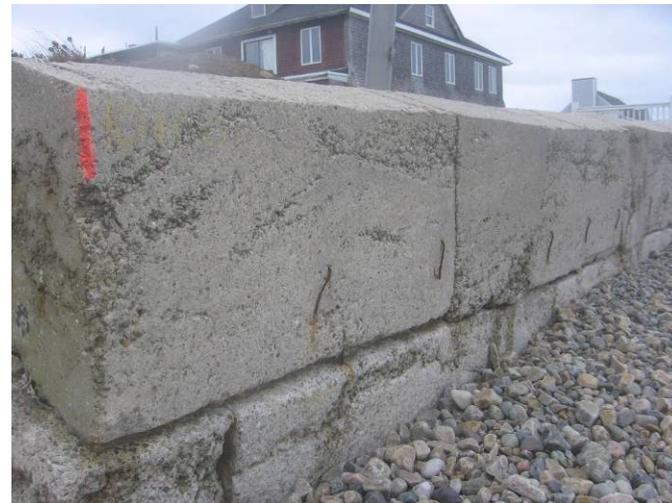
PHOTOGRAPH 36 - DETERIORATION OF CONCRETE

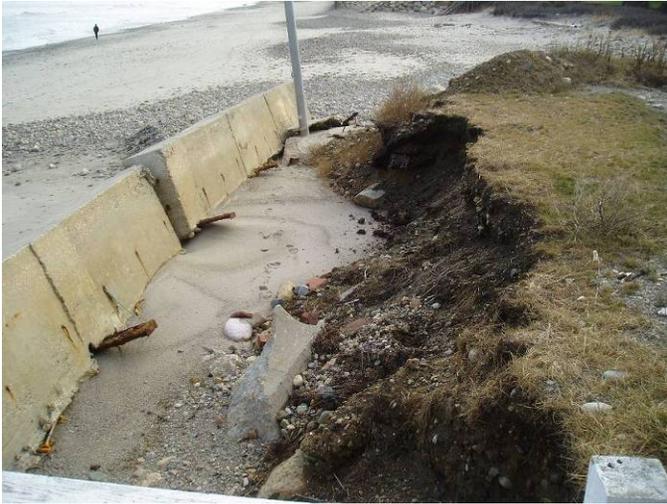
PHOTOGRAPH 37 - EROSION OF AREA BEHIND BLOCKS

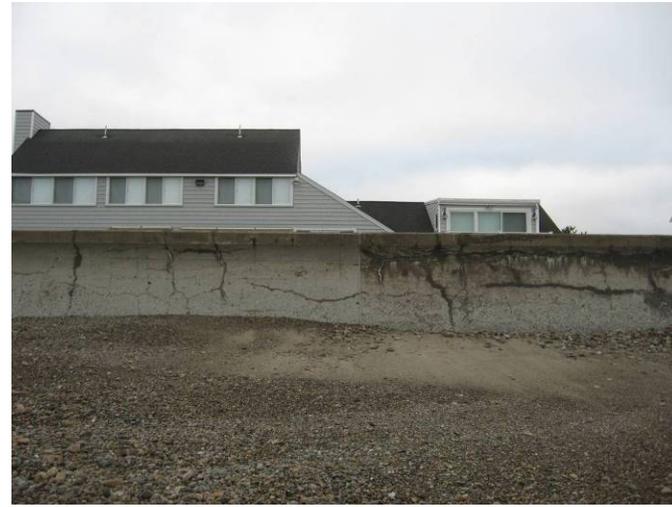
PHOTOGRAPH 40 - SIGNIFICANT CRACKING 202+00

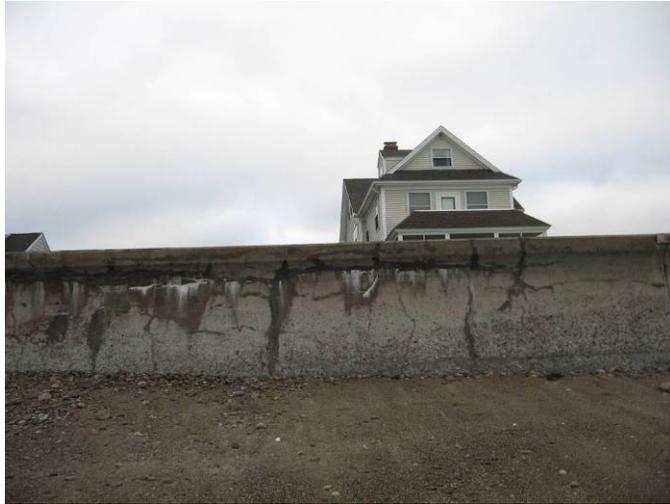
PHOTOGRAPH 41 - SIGNIFICANT CRACKING STA 203+00

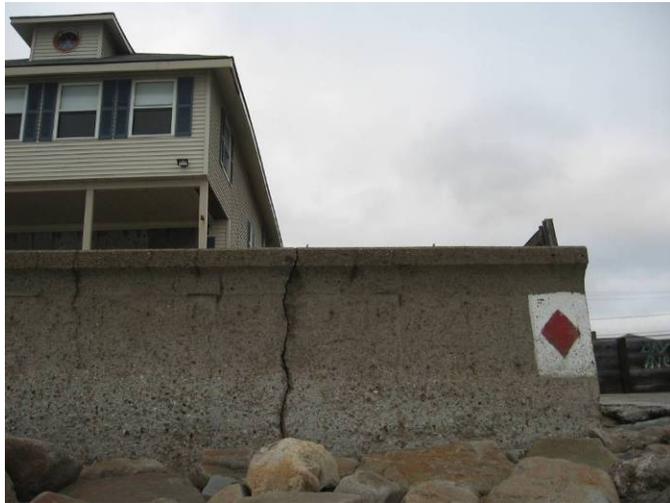
PHOTOGRAPH 42 - MAJOR CRACK IN WALL BEFORE RAMP
STA 209+00

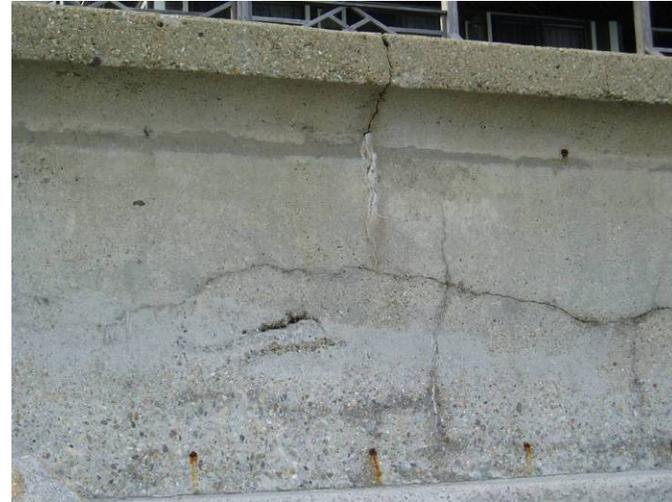
PHOTOGRAPH 53 - WALL TIES EXPOSED W/ STAINING AND CRACKING

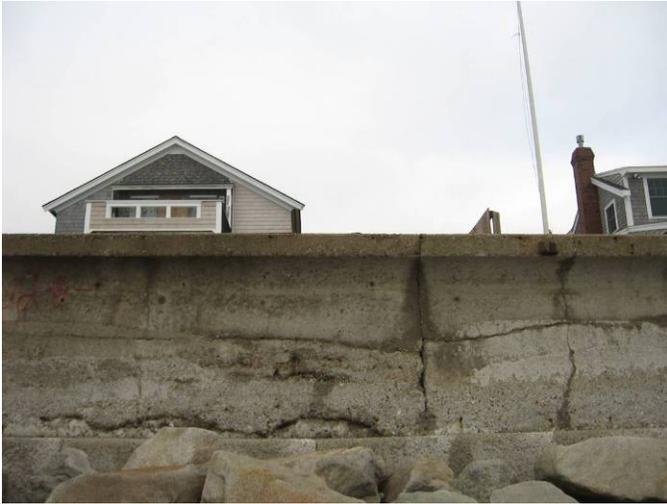
PHOTOGRAPH 55 - HEAVY CRACKING
