*Massachusetts Coastal Infrastructure  
Inventory and Assessment Report Update  
Project No. P13-2814-D05 (3841S)*

*Prepared for:  
Massachusetts Department of Conservation and Recreation  
Waterways Division  
Hingham, MA*

**South Shore - South**

**July 2015**

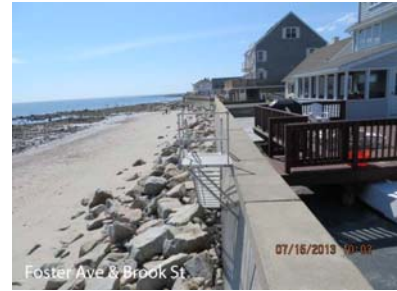
Condition / Ratings / Corrections:  
 Condition / Ratings:  
 Corrections: Upgrade Condition = B (Good)

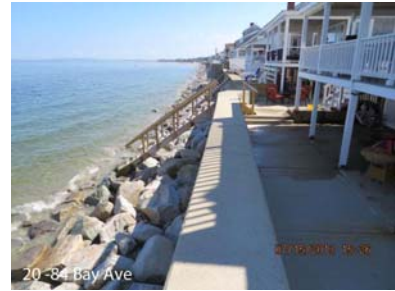
Condition / Ratings / Corrections:  
 Condition / Ratings:  
 Corrections: Revise length & incorporate new 210' section at #64 Bay Avenue

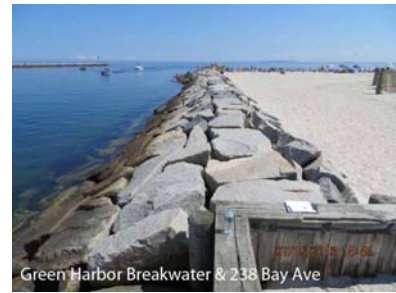
Condition / Ratings / Corrections:  
 Condition / Ratings:  
 Corrections: Downgrade Condition = F

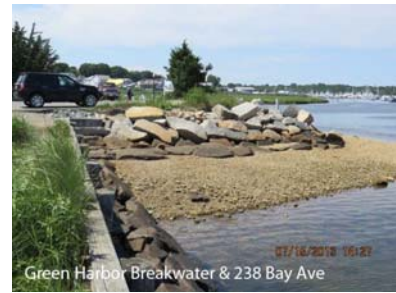
Condition / Ratings / Corrections:  
 Condition / Ratings:  
 Corrections: Downgrade Condition = D (Poor)
