STREAM REVIEW MEMO

TO: The Winsor at Millbrook Village LLC
FROM: Brad Holmes
DATE: November 29, 2023
RE: 50 Railroad Avenue, Duxbury

StreamStats Report

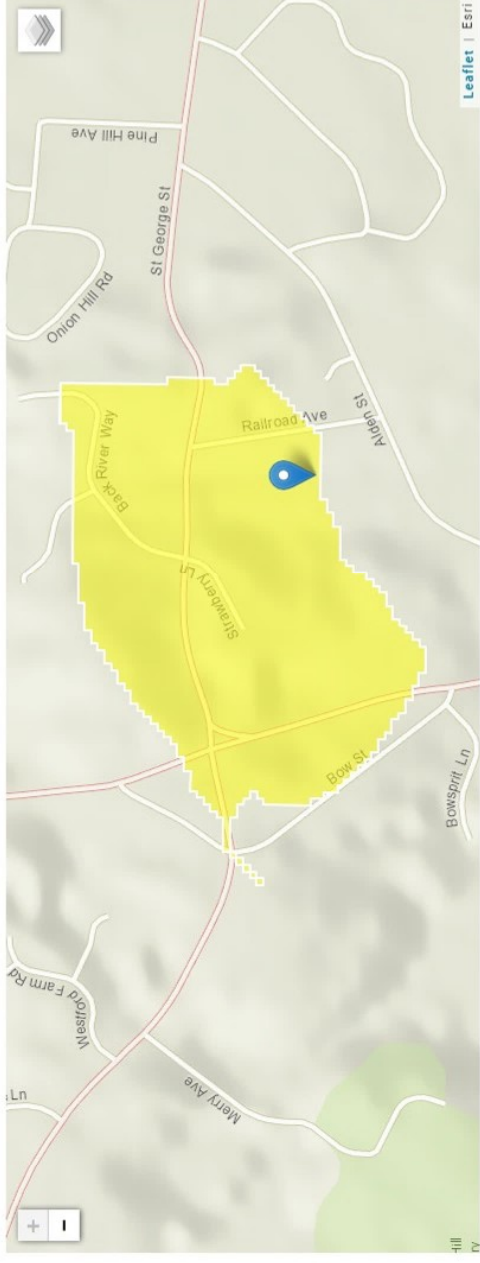
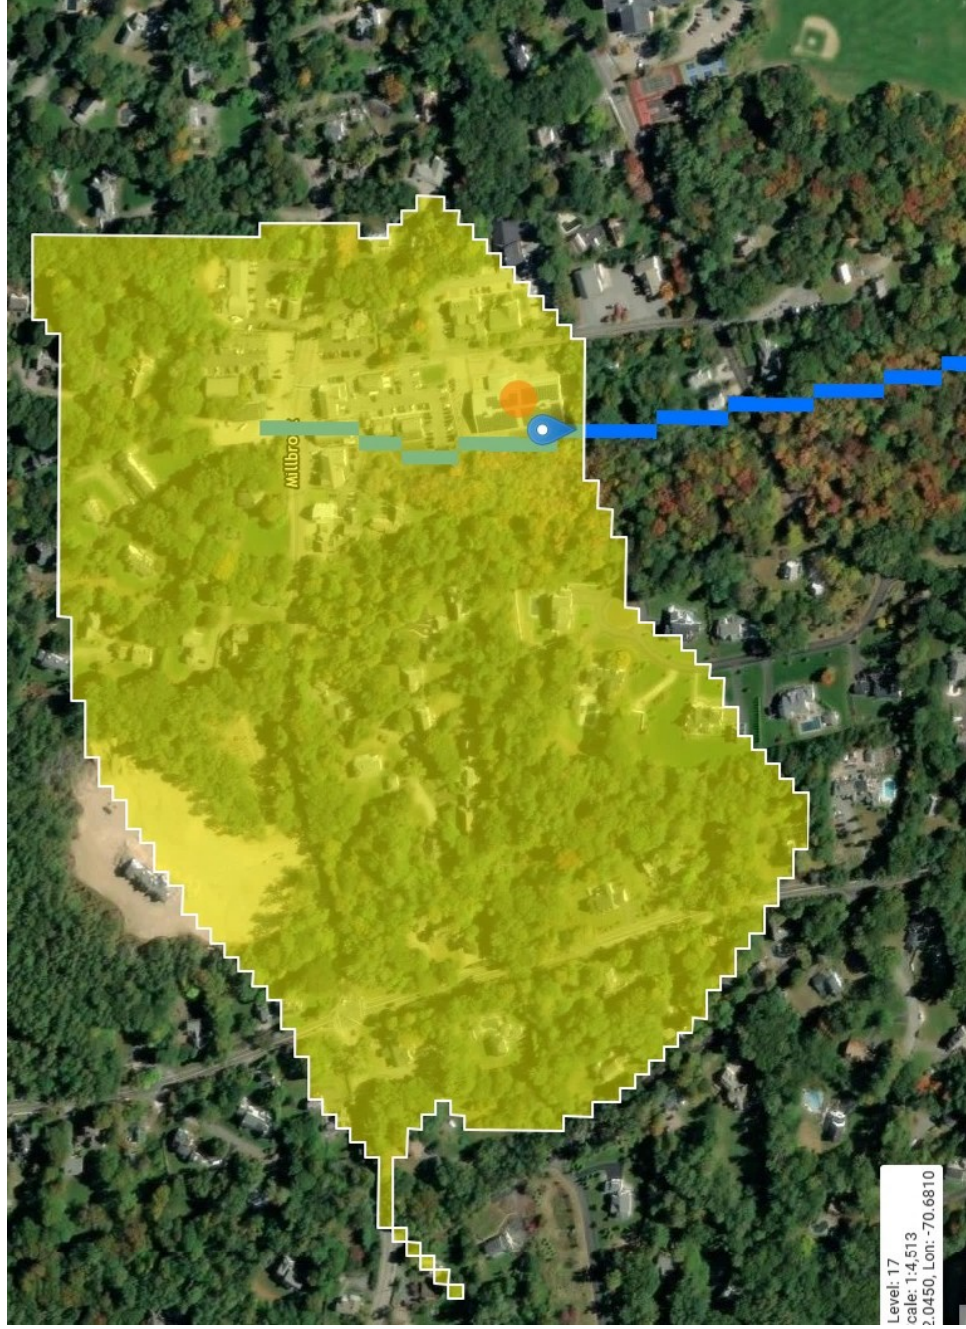
MA
MA20231122162940456000
42.04725, -70.68689
2023-11-22 11:30:02 -0500

Parameter Code	Parameter Description	Value	Unit
DRNAREA	Area that drains to a point on a stream	0.0937	square miles

- 50 Railroad Avenue has a calculated watershed area of 0.09 sq. miles. 50 Railroad Area is at/near the headwaters or beginning of the stream.
- Cooper Hill subdivision has a calculated watershed area of 0.11 sq. miles. Cooper Hill subdivision is located to the southwest of the site. The stream flows from north to south so the Cooper Hill subdivision is located downstream of 50 Railroad Avenue.

If the stream at the Cooper Hill subdivision is intermittent, then the portion of the stream located upgradient of the Cooper Hill subdivision cannot be greater than intermittent. Meaning, an intermittent stream is not possible to turn perennial when moving upstream. Moving upstream means the watershed area supporting the stream is smaller (see calculations above). Please note that for a stream to be considered perennial, a watershed area of at least 0.5 sq. miles is needed per 310 CMR 10.58. The watershed calculations at both locations are significantly under the 0.5 sq. mile threshold. Please refer to the attached Streamstats Maps for more information.

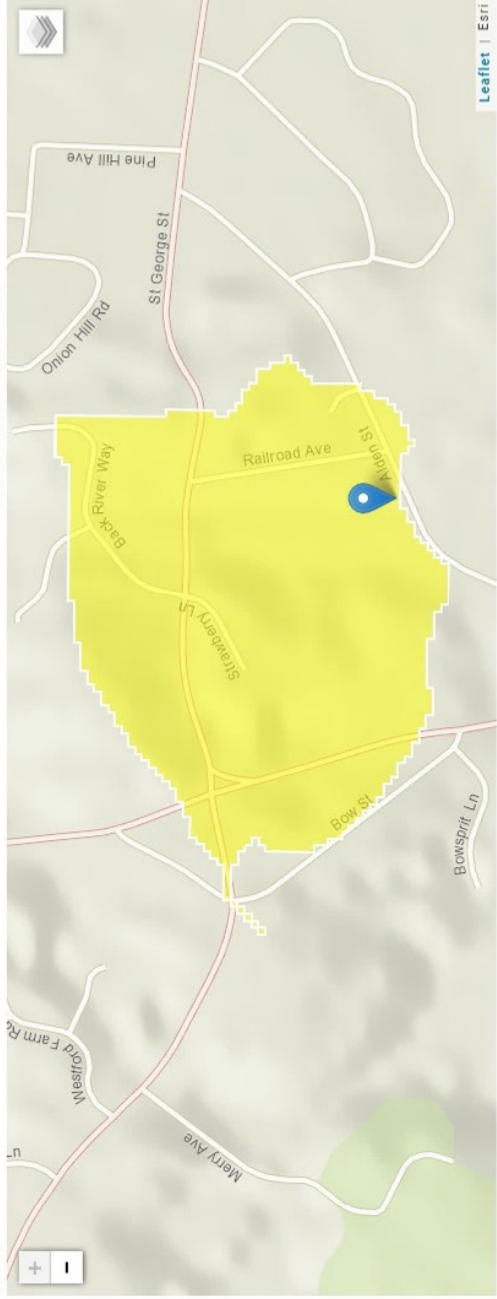
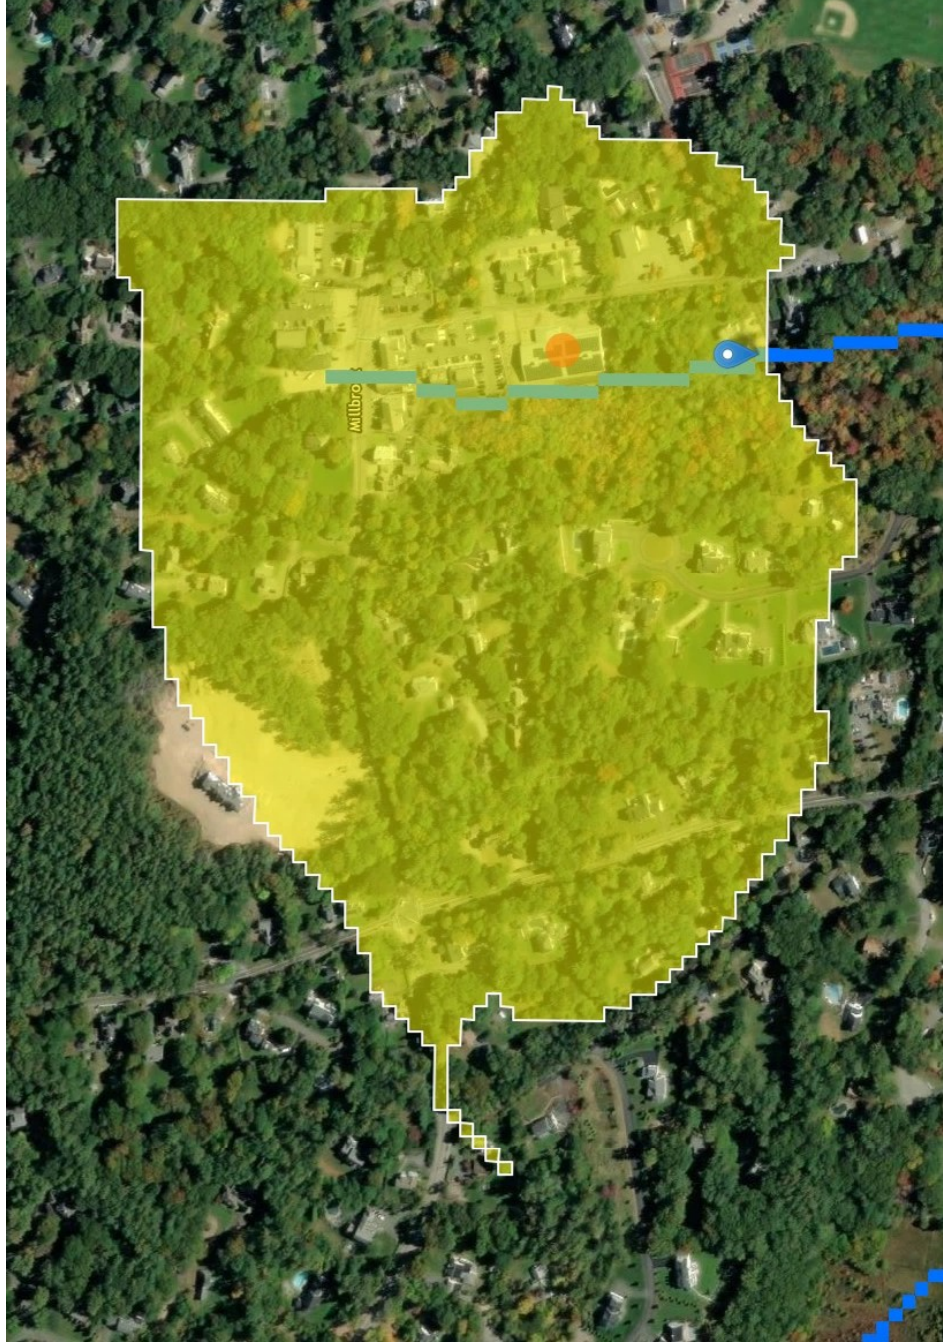
136-139 Alden Street

MA
MA20231122163529625000
42.04619, -70.68664
2023-11-22 11:35:50 -0500

Parameter Code	Parameter Description	Value	Unit
DRNAREA	Area that drains to a point on a stream	0.11	square miles
