MEMORANDUM

SUBJECT: Professional Wetland Services
Notice of Intent Review
50 Railroad Ave.
Duxbury, MA
Memo 2

50 Railroad Avenue
Duxbury, Massachusetts
Photographs Documented November 27, 2023
Wetland Strategies, Inc.

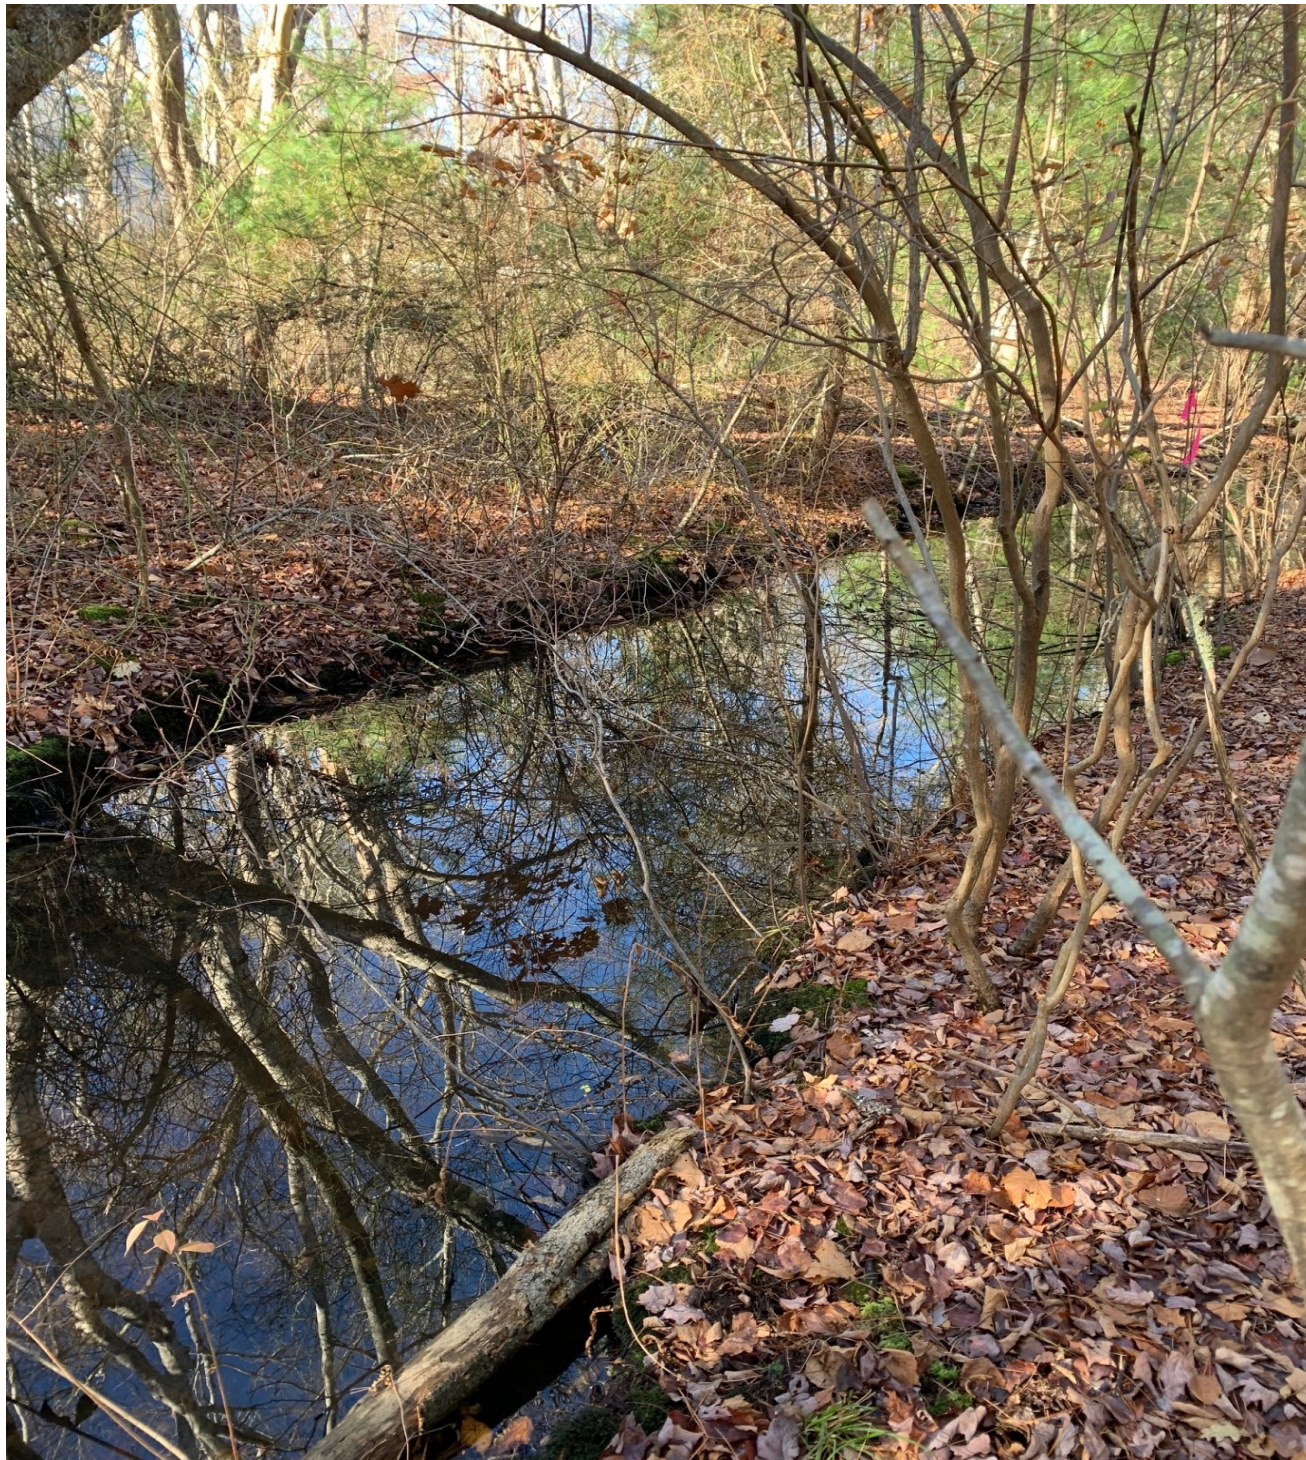
Moreover, SRE's subsequent letter dated December 7, 2023, includes drawing of various stream regimes sourced from USGS. Here too, the information is not sufficient to overcome the presumption of a perennial stream as shown on the USGS topographic map. While the USGS stream depictions are useful, there is no site-specific data or other photos which prove there are no pools/riffles. In comparison, WSI's site observations show a stream which appears to be similar enough to the depiction of a "pool" (see Photo 1).

Photo 1 showing second stream located west of site at flag IB 5

In sum, WSI recommends the Commission find that a perennial stream occurs within the vicinity of the proposed project. Photos submitted with this report show two streams to the west of the site. There are clear differences between the two streams shown on Photos 1 and 3 including:

- Only one stream is shown on the USGS map.
- Distinct differences in Inland Bank height and shape.
- Floating leaf litter on one stream only (see Photo 3) By comparison Photo 1 of the disputed stream shows a lack of any leaf litter which is likely due to flowing conditions.
- Difference in channel widths.
- Visual evidence of flow by WSI and others at the Alden Street culvert.

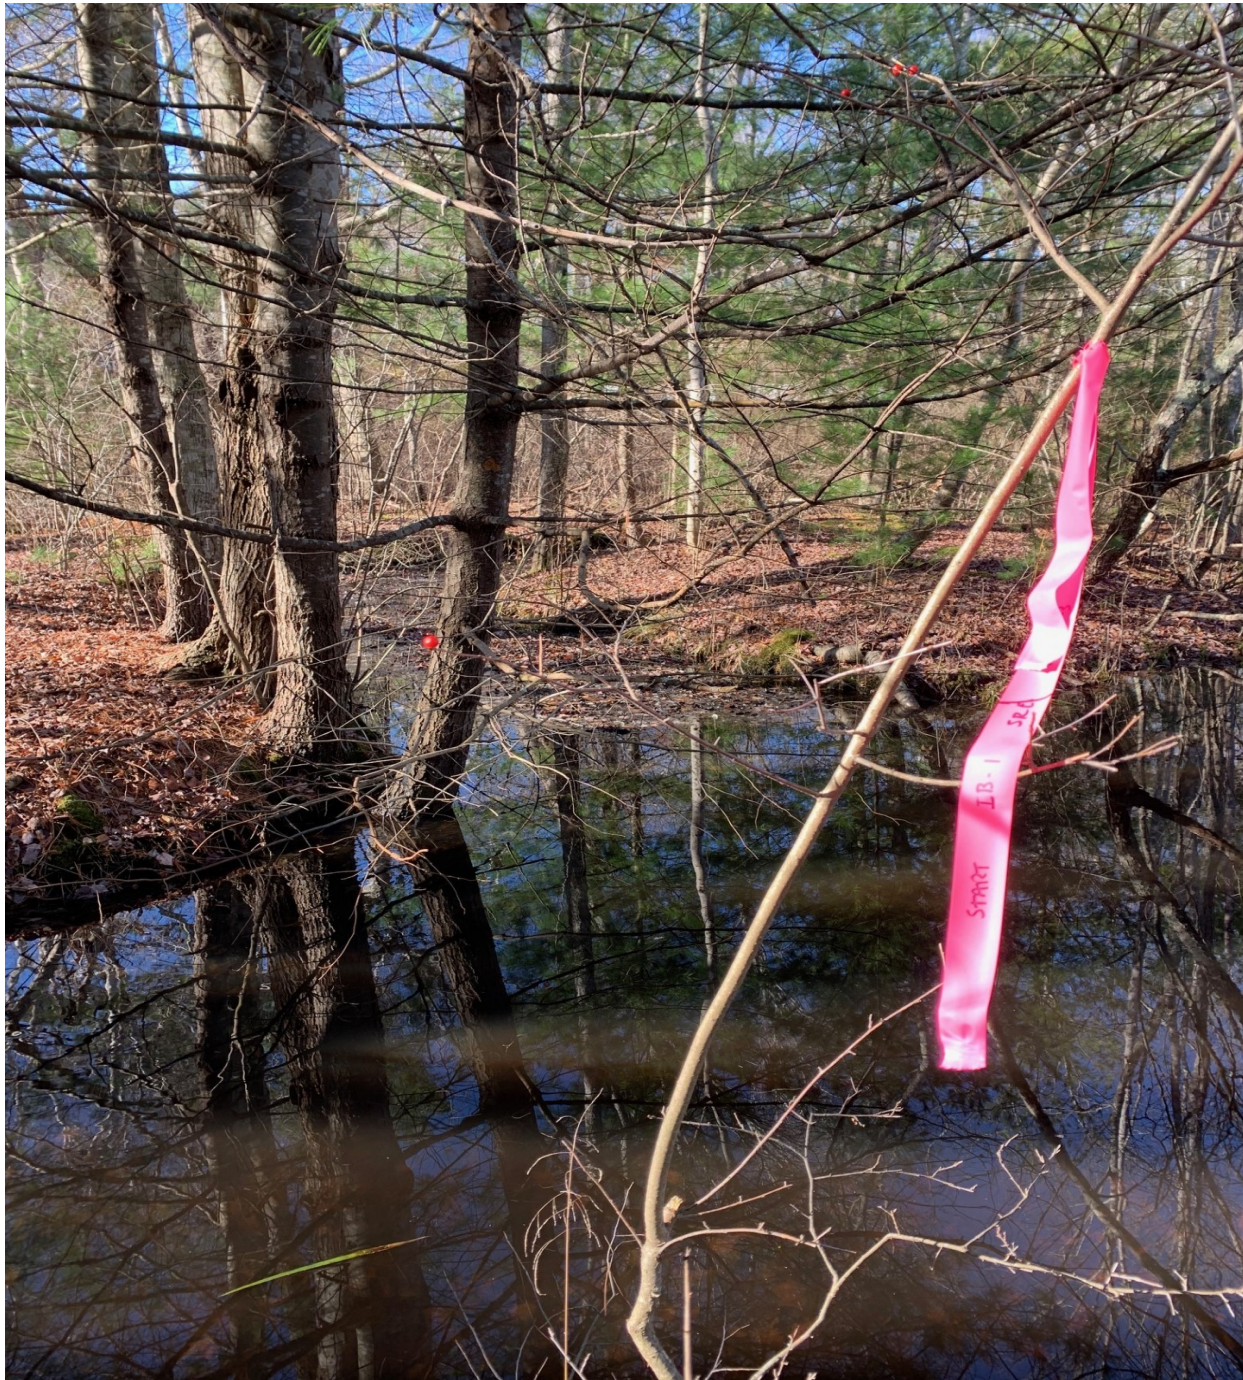
Photo 2 at flag IB1 at confluence of 3 streams.
