# McNeil Dump: Initial Landfill Assessment and Duxbury Municipal Landfill Initial PFAS Sampling

Weston & Sampson Engineers, Inc.

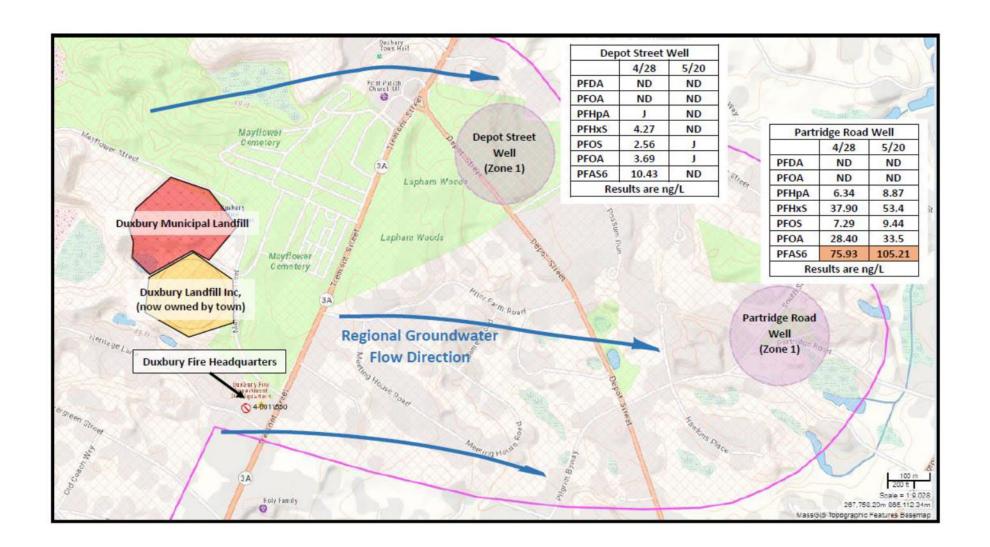
#### Nearest Water Supply Wells

- BOH database: no private drinking wells within 500 feet of landfills or plume
- Town's Depot Street PWS well located over 2,000 feet northeast.
- Partridge Street PWS Well located over 4,000 feet southeast
- Both wells off-line
- Depot Street (Manganese) Partridge (PFAS)

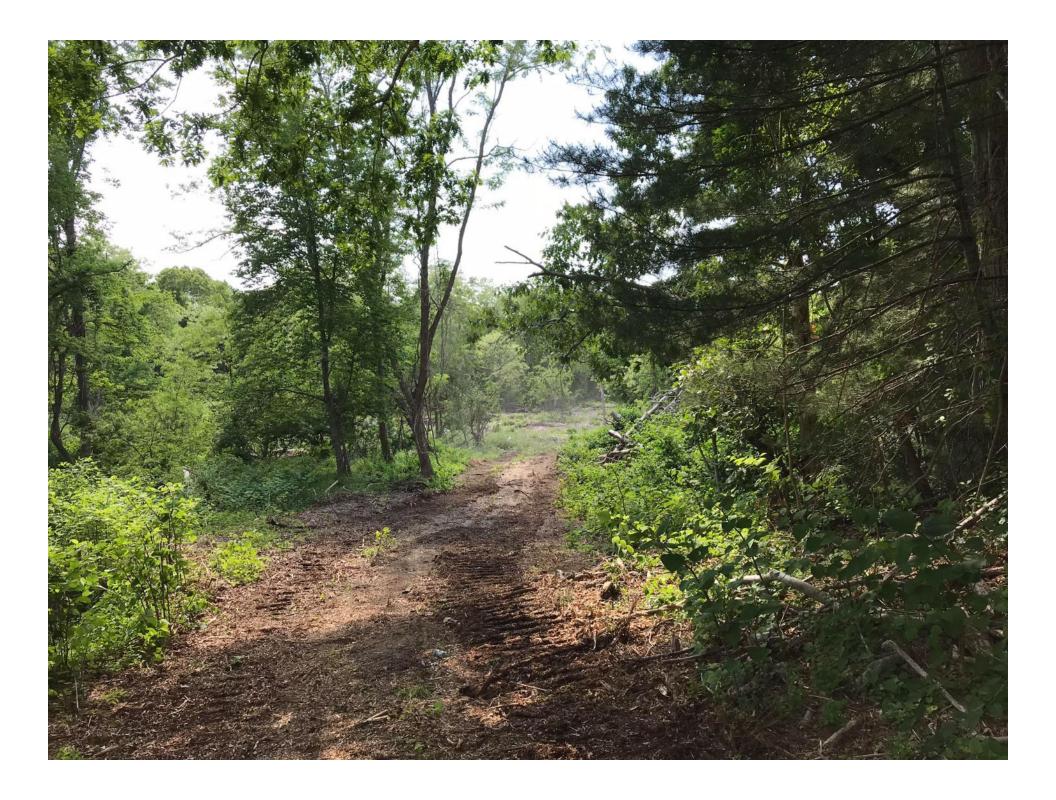
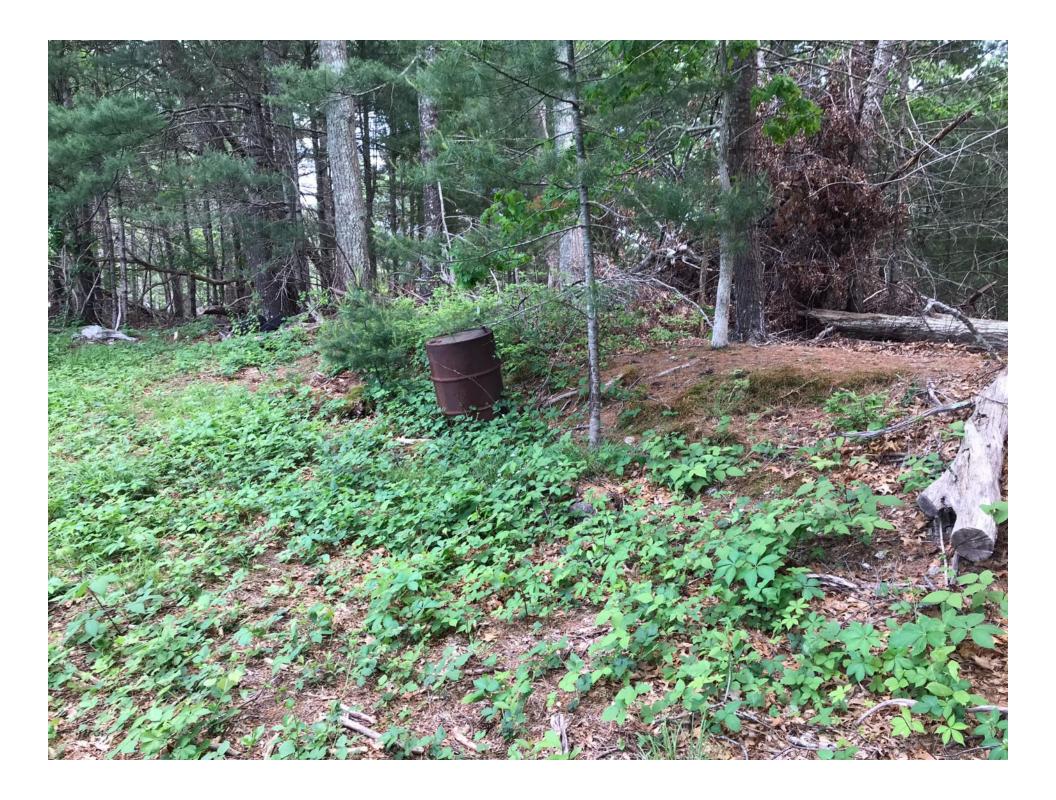
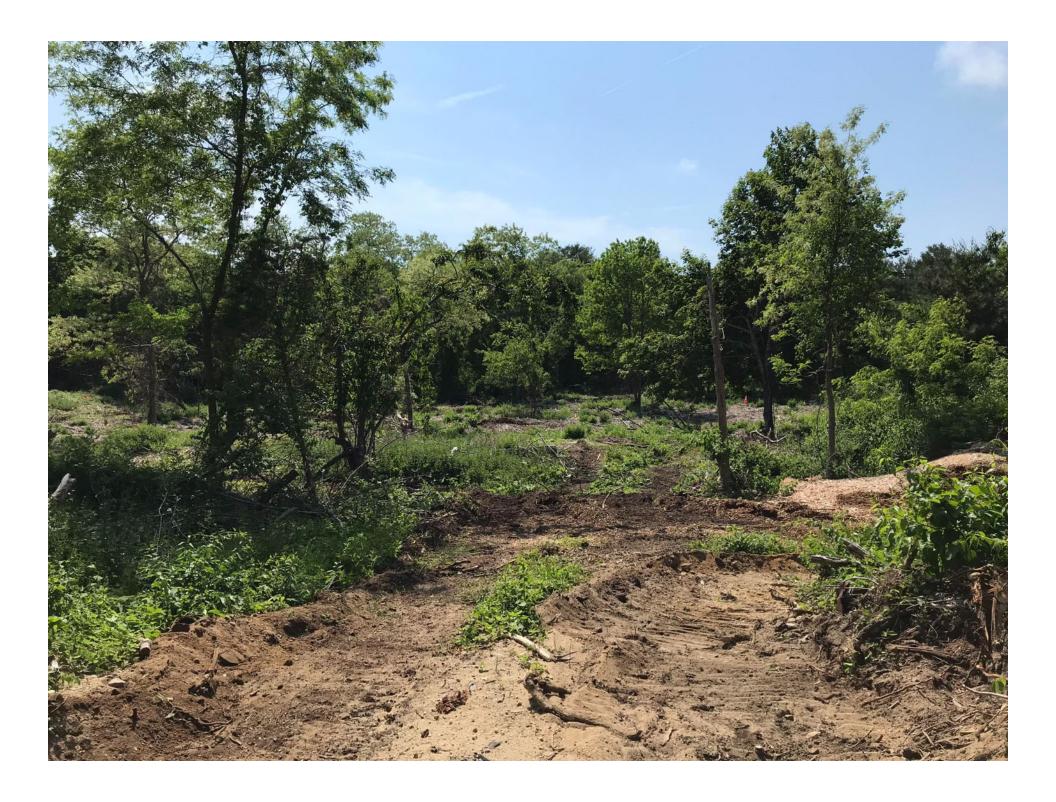
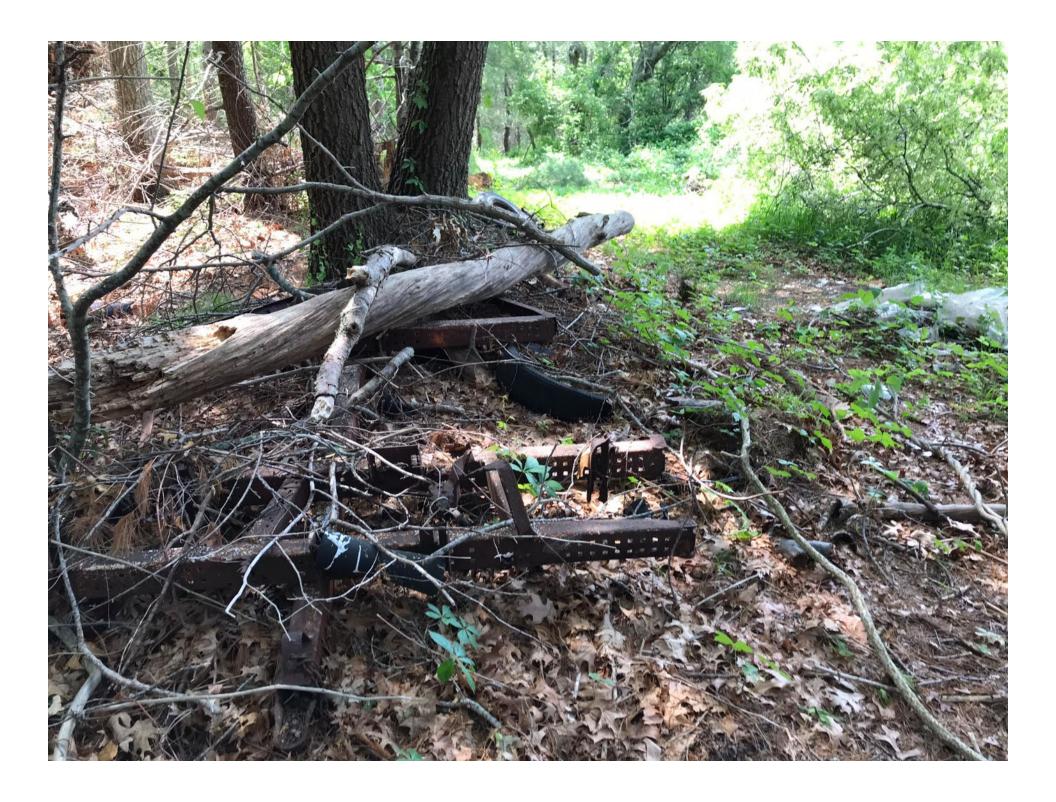
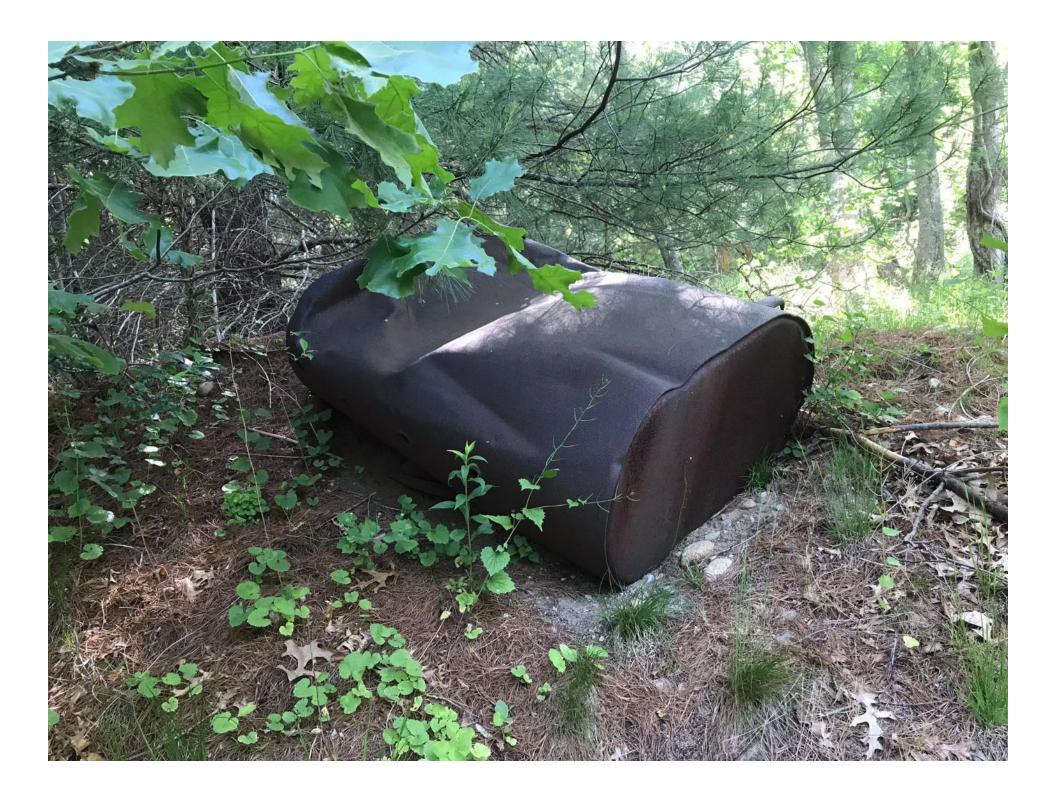
#### McNeil Dump Initial Recon

- Scattered Surface Debris: metal, car parts, empty steel tanks, unlabeled empty drums, wood and concrete waste
- Nine historic monitoring wells found
- Four viable for sampling

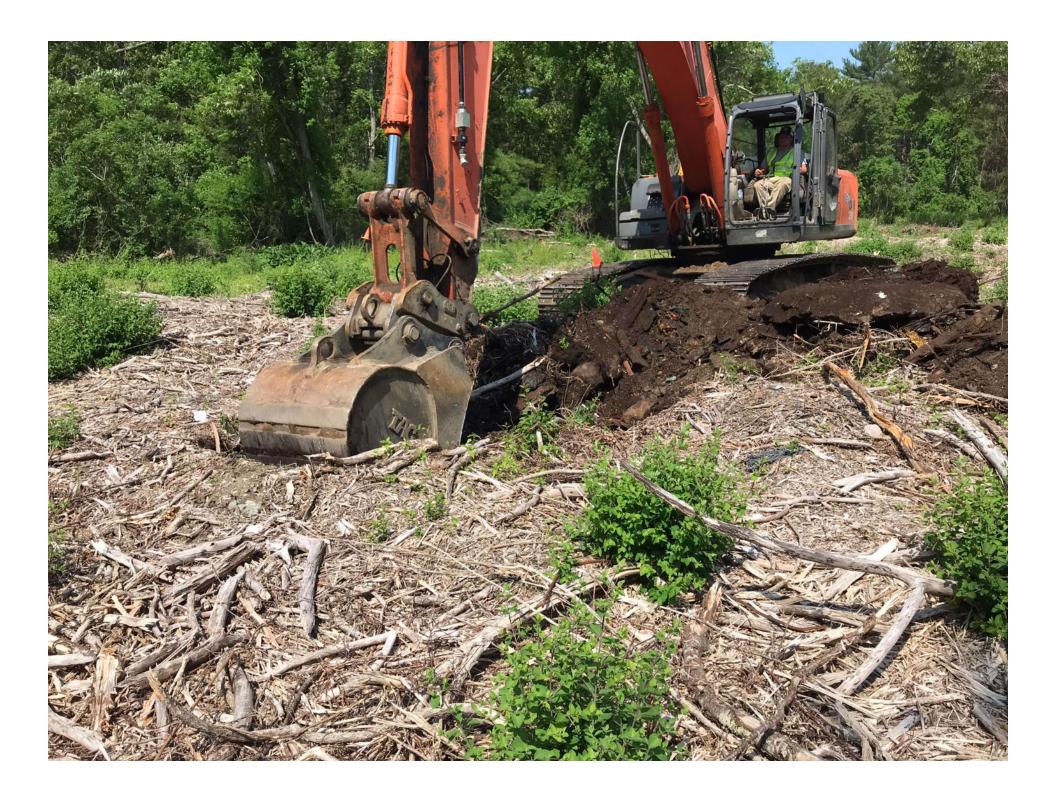
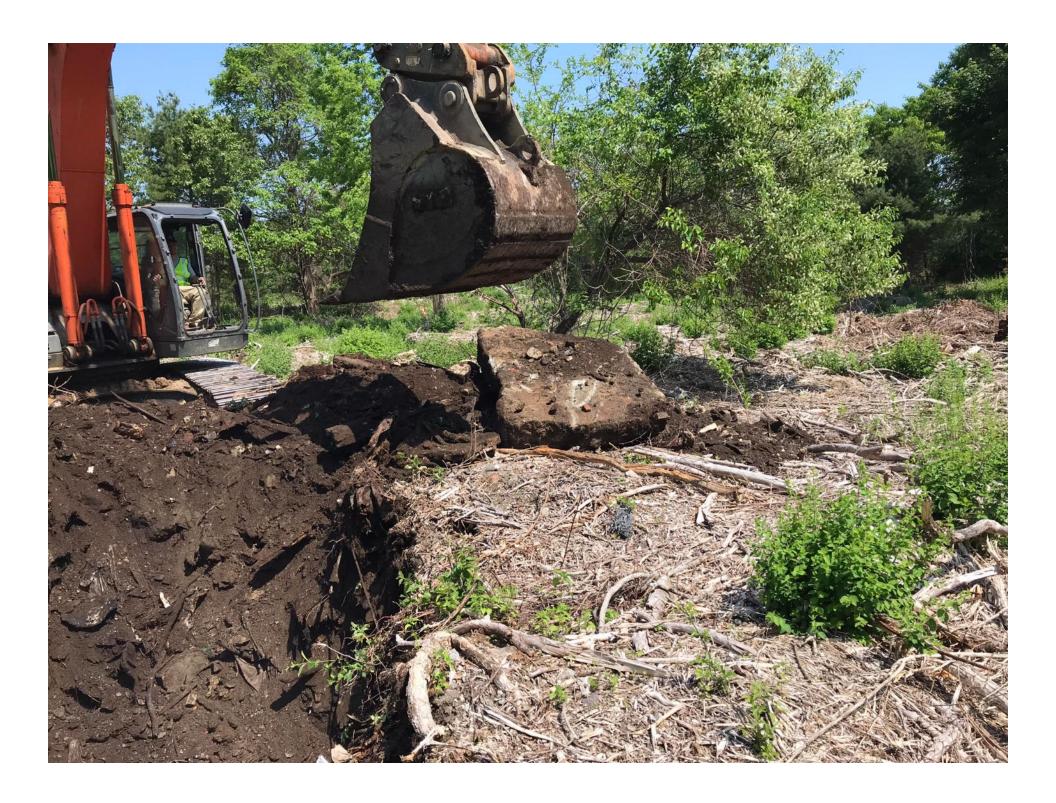
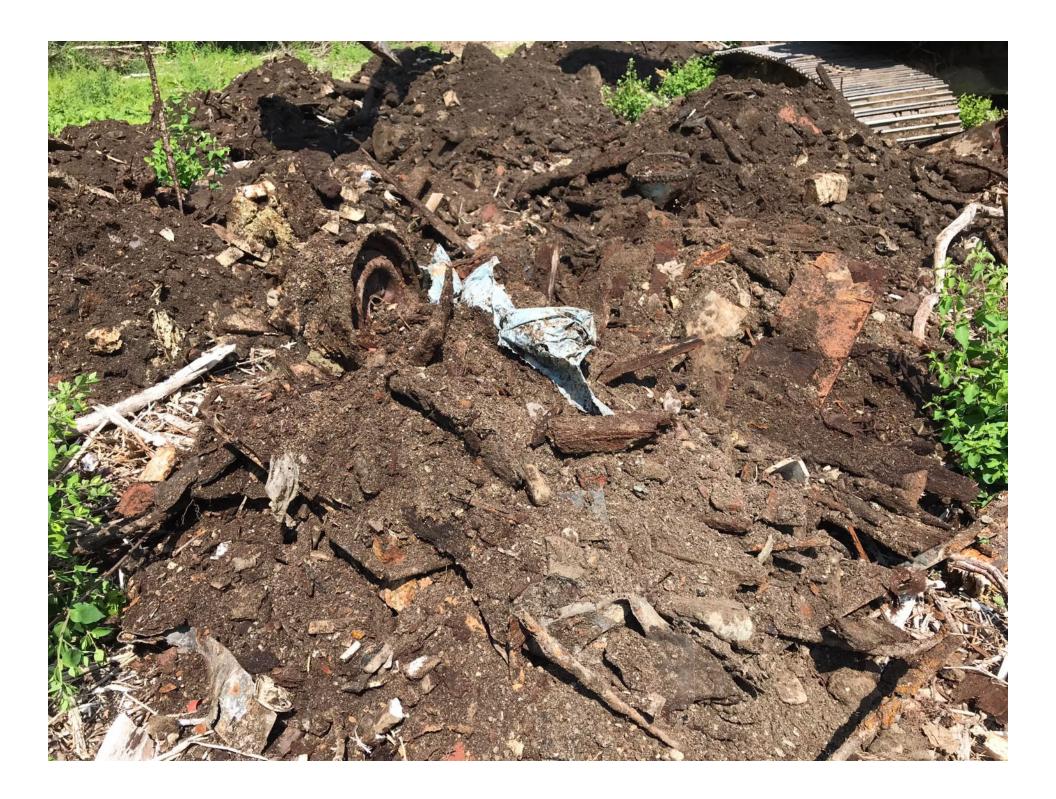
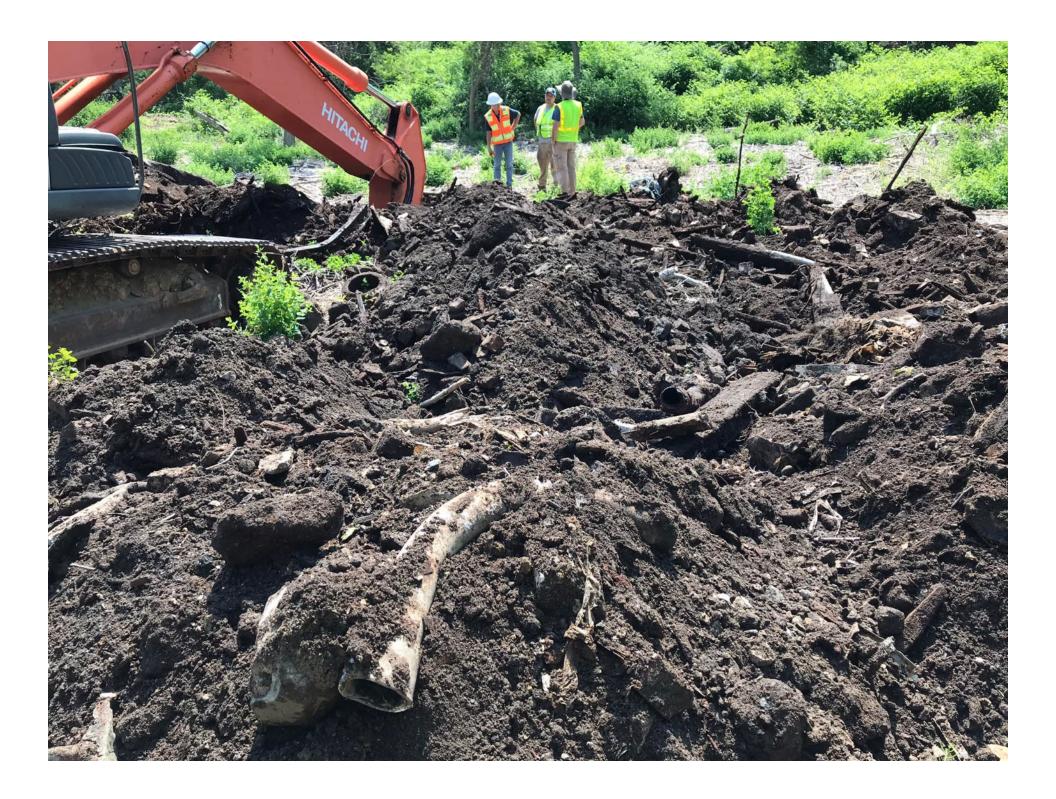
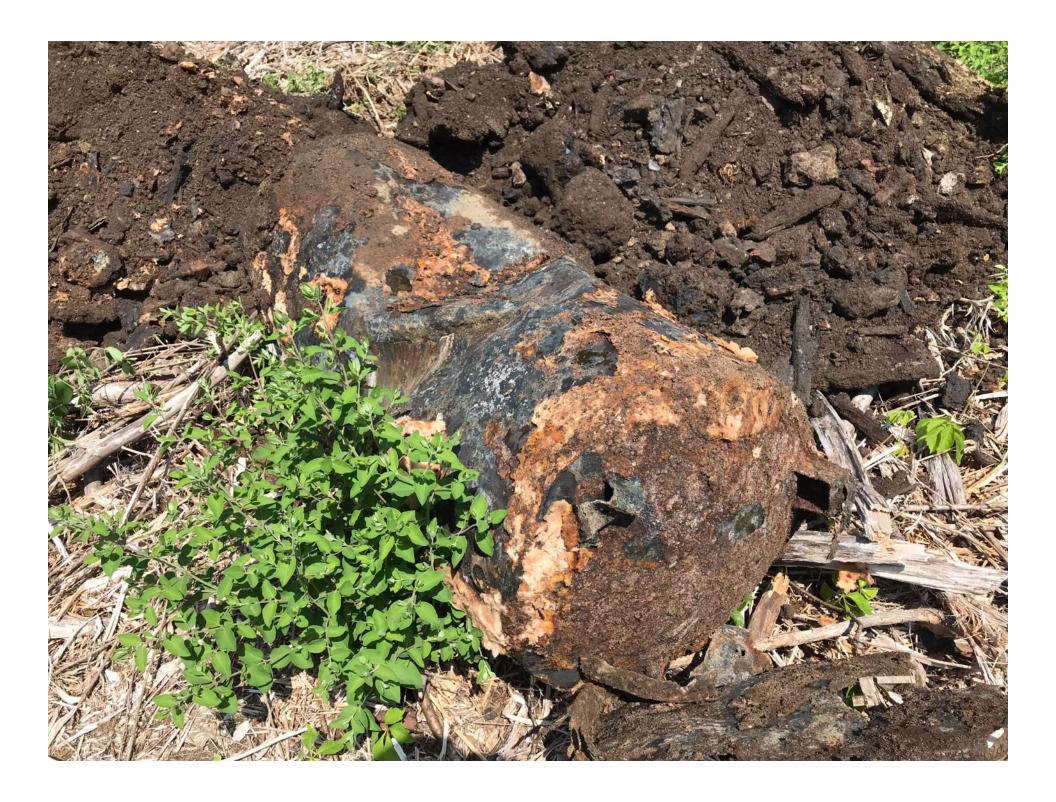
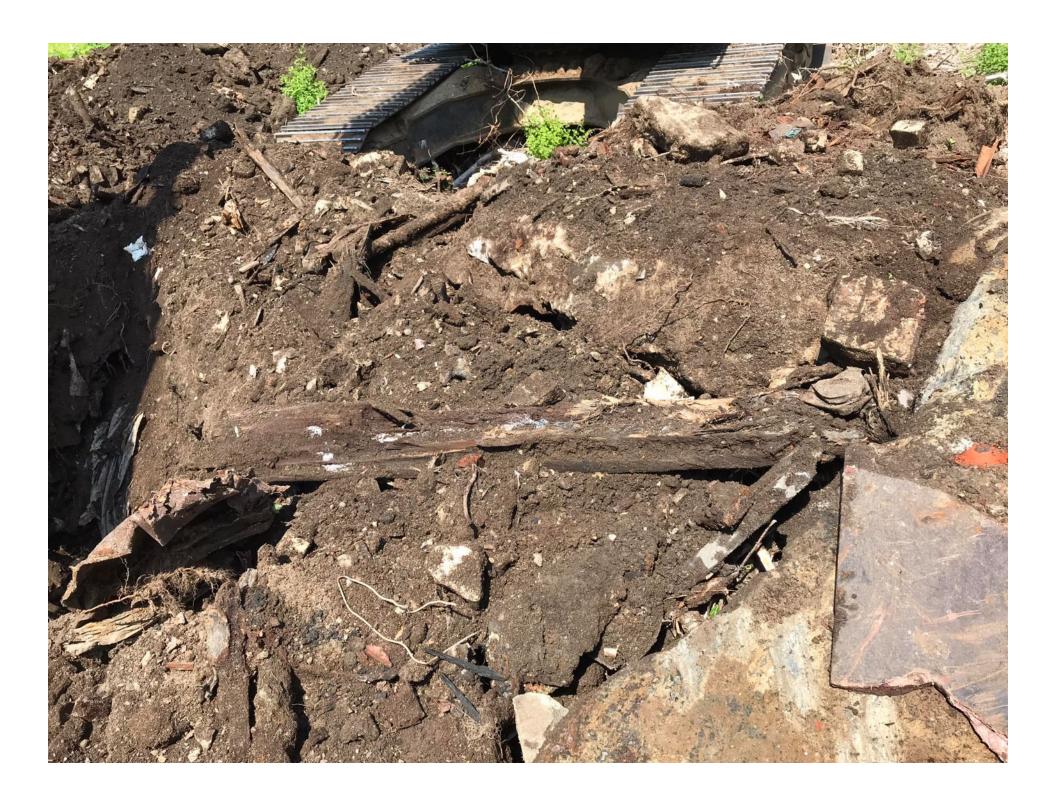
#### McNeil Dump Waste

- 18 Test Pits advanced 5 to 20 feet deep
- Waste observed: brick, metal, crushed drums, plastic, textiles, foam, glass, bottles, wood debris, melted asphalt material, and roof shingles
- Some of the debris (crushed drums, plastic, textiles, melted asphalt material) potential PFAS source debris
- Suspect ACM: fire brick, tiles, and insulation
- Petroleum odors were observed in multiple test pits

- Maximum vertical limit of waste: 19 feet below grade surface in central portion of dump
- Test pits and boring logs defined horizontal limits of waste to north, northeast, south and west
- Additional delineation of waste is required along the western and northwestern property line

- Additional test pits horizontal extent of waste
- PFAS groundwater delineation to the west
- Seasonal perimeter groundwater sampling to support closure (4 rounds)
- Complete Phase II Comprehensive Site Assessment Report, Corrective Action Alternatives Analysis, Corrective Action Design, Bidding. 2022 to 2025

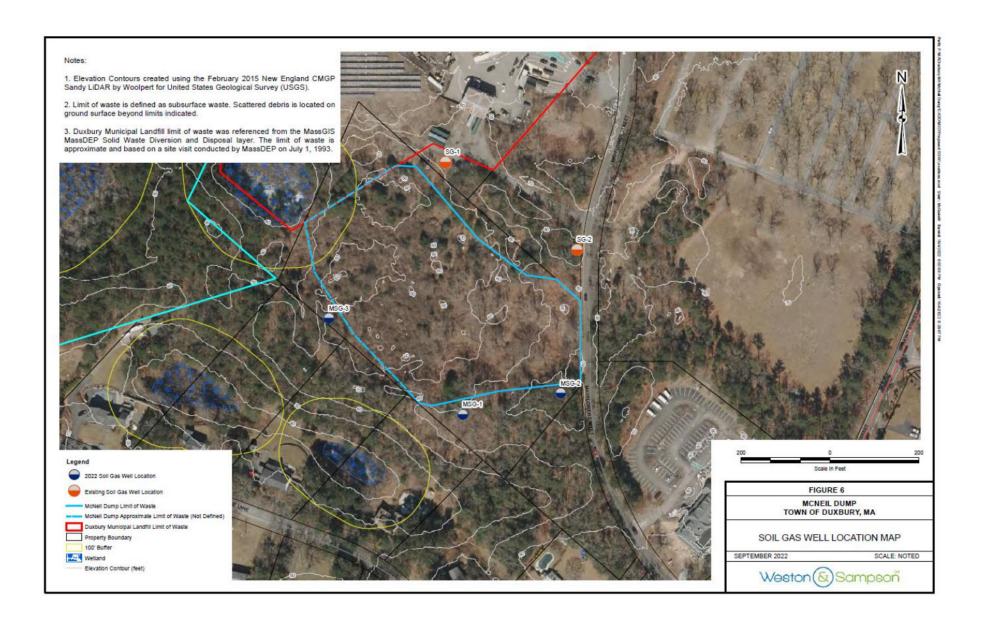
#### McNeil Soil Gas Monitoring Results

- 3 new soil gas wells installed and sampled.
   Two existing wells sampled.
- Sampled for methane, carbon dioxide, oxygen, hydrogen sulfide volatile organic compounds
- Detections are very low or just above instrument detection limits and are likely close to background
- Landfill gas concentrations are not considered a concern

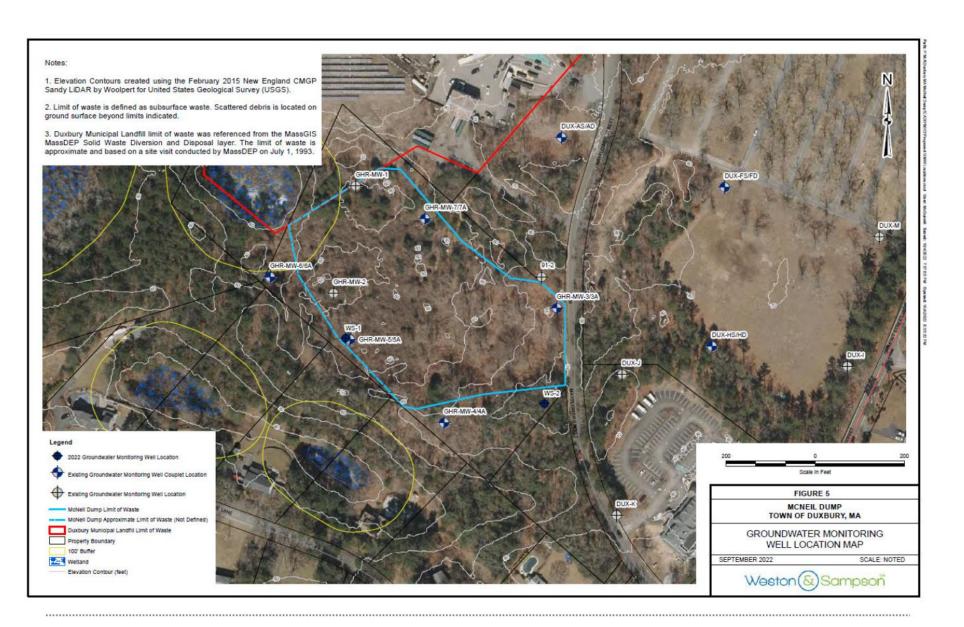
#### McNeil Dump GW Sampling

- Two additional perimeter wells installed WS-1 (30 feet) and WS-2 (50 feet below grade)
- WS-1 screened immediately below LF waste
- Two existing perimeter wells also sampled (GHR-MW-7 and MW-91-2)
- Samples (4 total) analyzed for PFAS, 1,4 dioxane, VOCs, metals (total)

- Metals and VOCs results below drinking water (GW-1) and GW-3 standards (protective of surface water)
- 1,4 Dioxane not detected. VOCs not detected
- PFAS not detected in 2 of 4 wells
- MW- 91-2- PFAS detected well below drinking water standard
- WS-1-PFAS above drinking water standard but well below GW-3 standard (protective above surface waters).
- WS-1 installed immediately below waste.

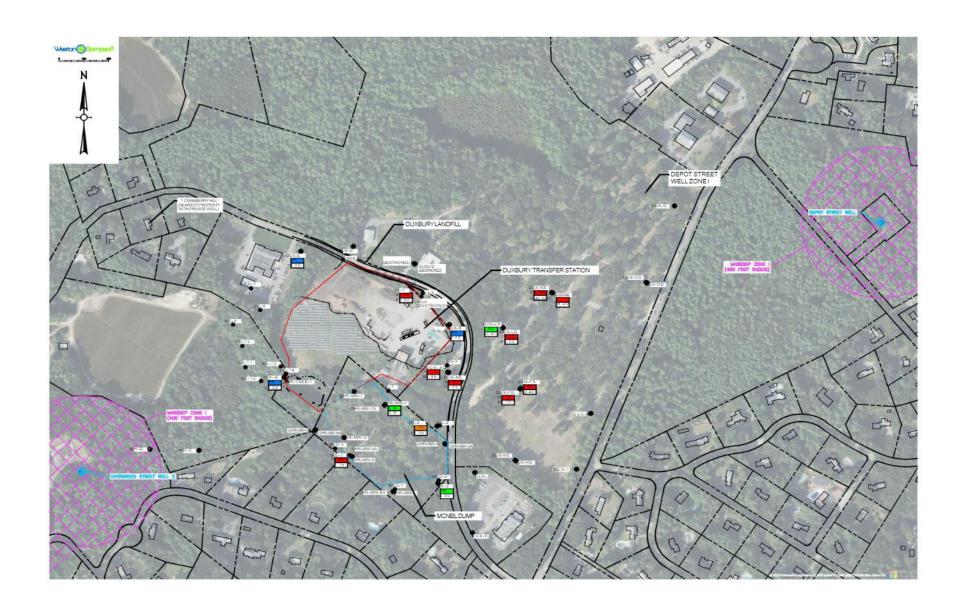
### Duxbury Landfill GW Sampling Results

- Sampled 8 existing wells for PFAS and 2 for 1,4 dioxane - July 2022
- 1,4 dioxane in two wells (DUX-NS and DUX-ND) above drinking water standards consistent with previous results (May 2022)
- PFAS detected above drinking water standards in all 8 wells. Highest levels adjacent to Duxbury Municipal LF
- May and July results similar concentrations.
- MWs FS and FD additional wells sampled in July

- Additional PFAS evaluation to confirm nature and extent of impacts
- Delineation, horizontal and vertical extent of PFAS
- Remaining wells in network to be sampled
- Additional field survey
- Evaluate potential impacts to nearby irrigation wells (sampling)
- Evaluate potential for additional sources to PWS (such as fire station property)
- Evaluation of potential remedial options including PFAS treatment at Depot Street PWS and possible source area treatment at Duxbury Municipal landfill

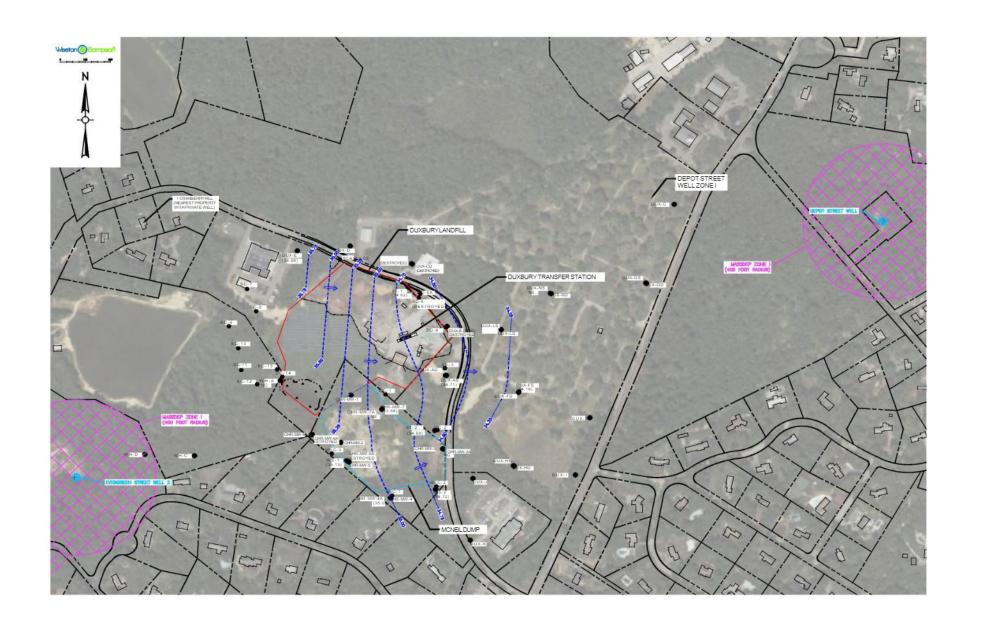
# Groundwater Gauging and Flow Survey

- MW network at both McNeil and Dux LF gauged and located, July and Aug 2022
- GW depths range from 10 to 52 feet below well casings.
- GW flow to the east, consistent with previous GW flow surveys and 1988 IES evaluation
- Additional survey required to incorporate additional wells in network and surface elevations
