AMORY ENGINEERS, P.C.

Subject: Duxbury Beach Seawall Assessment and Replacement Phasing Plan

Duxbury Beach Seawalls - 2020 Condition Assessment

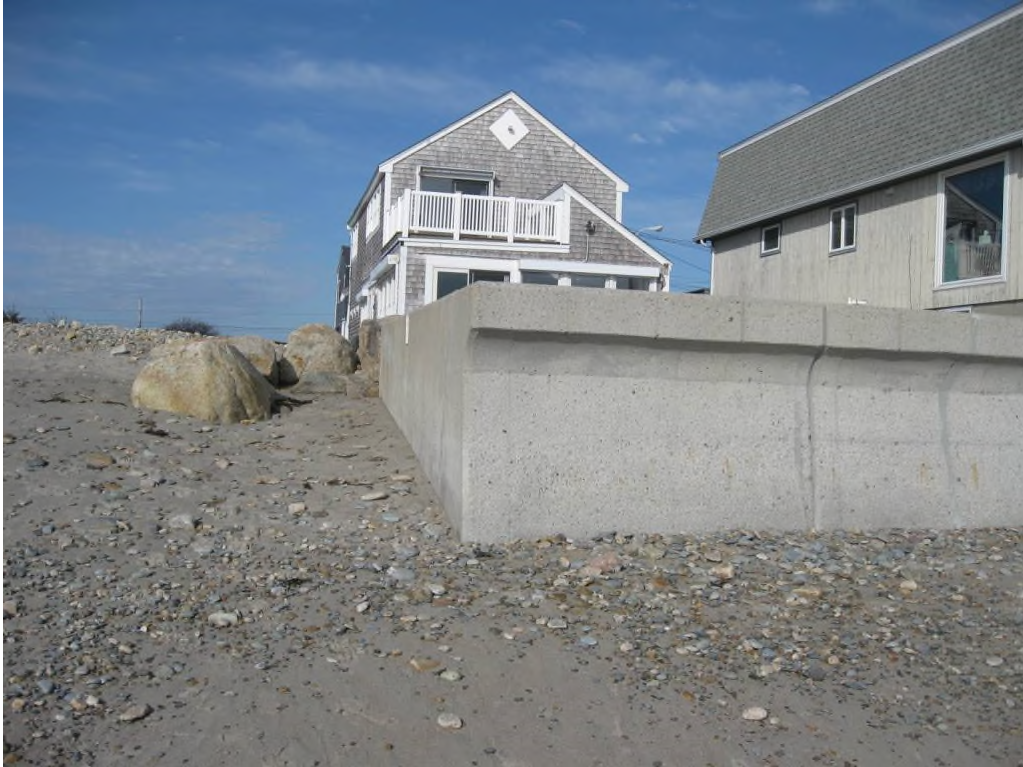
Section 1

Section Number	Condition Description	Condition Rating
South Low Wall		
1	Newer concrete (circa 2007), a couple of minor vertical cracks	8
2	Minor horizontal and vertical cracks and efflorescence	7
3	Minor horizontal and vertical cracks and efflorescence, one area with about a 5'-6' long larger horizontal crack	5
4	Minor horizontal and vertical cracks and efflorescence	7
5	Minor horizontal and vertical cracks and efflorescence	7
6	Large cracks in northern 10'-15' of section, adjacent to joint	3
7	Minor horizontal and vertical cracks and efflorescence	7
8	Major horizontal cracks throughout entire section	2
9	Minor and intermediate horizontal and vertical cracks and efflorescence	4
10	Major horizontal crack along north 2/3 of section. Joint between 10 & 11 moved in March 2018	3
11	Minor horizontal and vertical cracks and efflorescence, intermediate vertical crack at about mid-point	4
12	Minor horizontal and vertical cracks and efflorescence, major vertical crack and spall at about mid-point, minor settlement	5

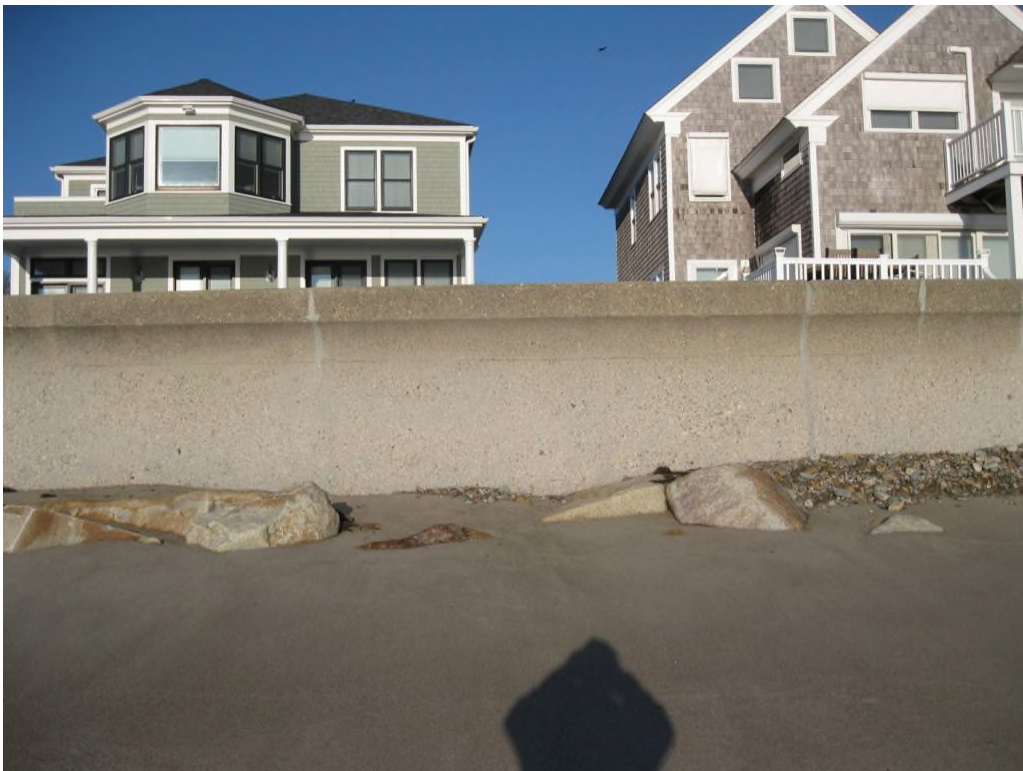
Section 33 – 34

33	Minor horizontal and vertical cracks and efflorescence, a couple of intermediate vertical cracks	6
34	Movement seaward at joint with 33; intermediate vertical cracks throughout, major crack & spalling at joint with 35	4
35	Significant seaward movement at joint with 34; section leaning seaward; revetment in front; major crack & spalling at joint with 36	3
36	Section leaning seaward; revetment in front; minor horizontal and vertical cracks and efflorescence	4
37	Section leaning seaward; revetment in front; minor horizontal and vertical cracks and efflorescence	4
38	Section leaning seaward; revetment in front; intermediate and major vertical cracks and efflorescence	3
39	Section leaning seaward; revetment in front; minor horizontal and vertical cracks and efflorescence	4
40	Section leaning seaward; revetment in front; intermediate and major vertical cracks and efflorescence, major movement at joint with 41	4

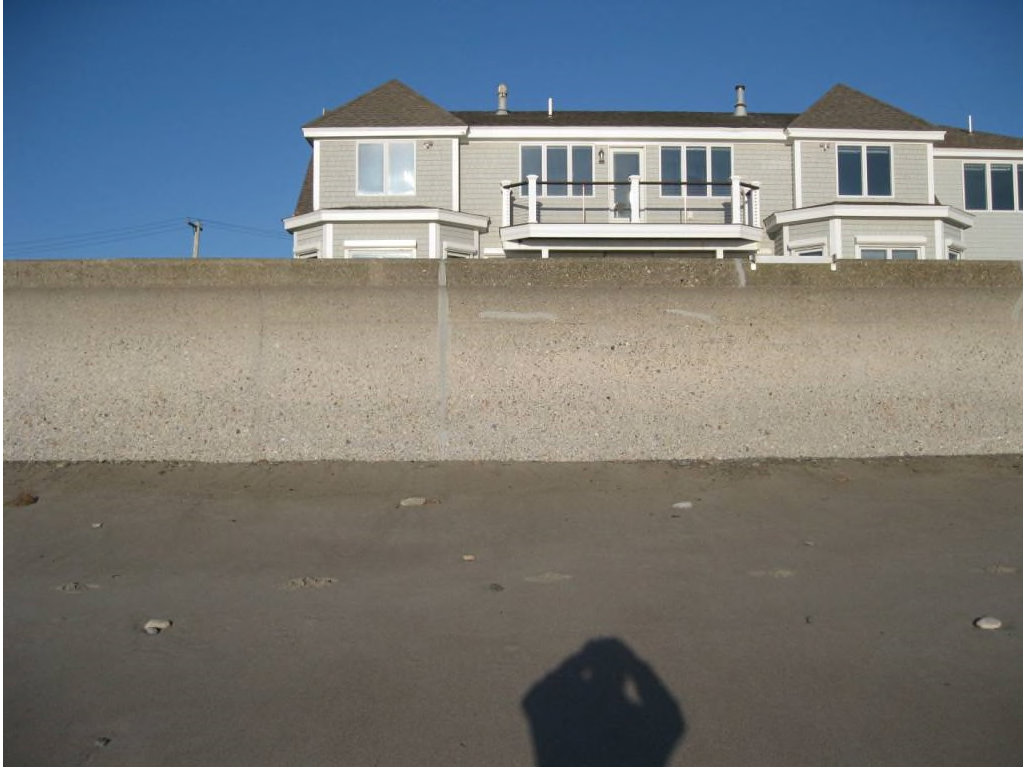
Section 41

Section Number	Condition Description	Condition Rating
41	Minor horizontal and vertical cracks and efflorescence, intermediate vertical crack about mid-point	4
42	Minor & intermediate horizontal and vertical cracks and efflorescence	6
43	Minor horizontal and vertical cracks and efflorescence	7
44	Minor & intermediate horizontal and vertical cracks and efflorescence	6
45	Minor horizontal and vertical cracks and efflorescence	7
46	Minor & intermediate horizontal and vertical cracks and efflorescence	6
47	Minor & intermediate horizontal and vertical cracks and efflorescence	6
48	Minor horizontal and vertical cracks and efflorescence	7
49	Minor horizontal and vertical cracks and efflorescence	7
50	Minor & intermediate horizontal and vertical cracks and efflorescence	6
51	Minor & intermediate horizontal and vertical cracks and efflorescence	6
52	Minor & intermediate horizontal and vertical cracks and efflorescence	5

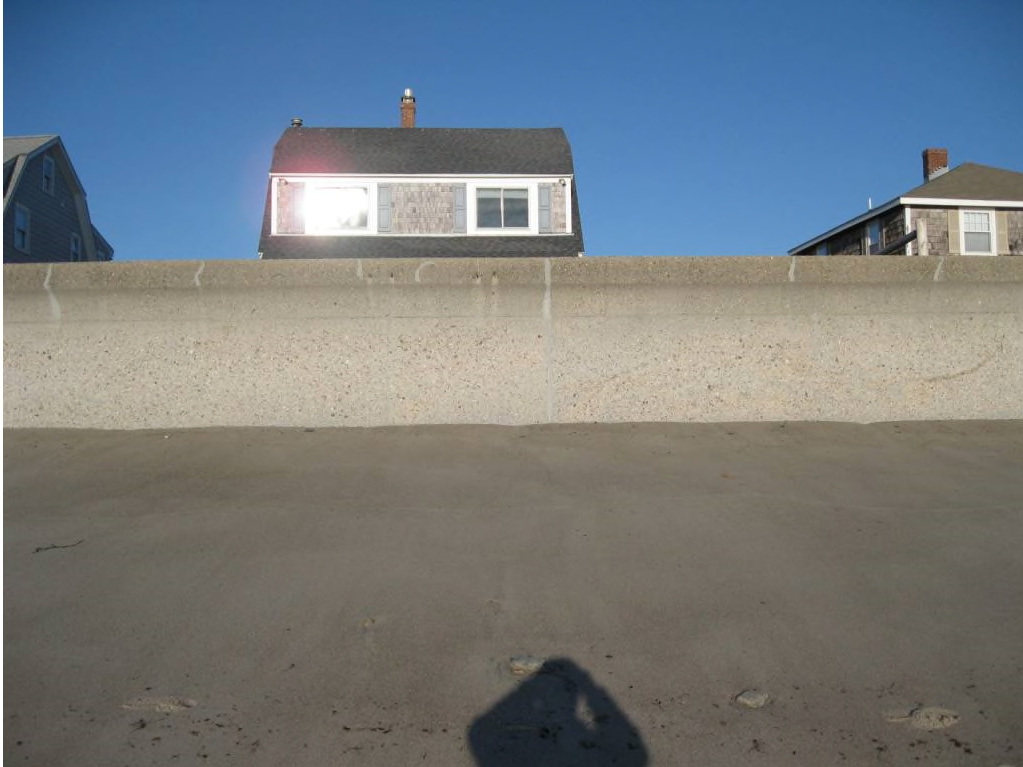
Section 53

53	Minor horizontal and vertical cracks and efflorescence	7
54	Minor & intermediate horizontal and vertical cracks and efflorescence	5
55	Minor & intermediate horizontal and vertical cracks and efflorescence	5
56	Minor & intermediate horizontal and vertical cracks and efflorescence	4
57	Minor & intermediate horizontal and vertical cracks and efflorescence, some major cracks	4
58	Minor & intermediate horizontal and vertical cracks and efflorescence	5

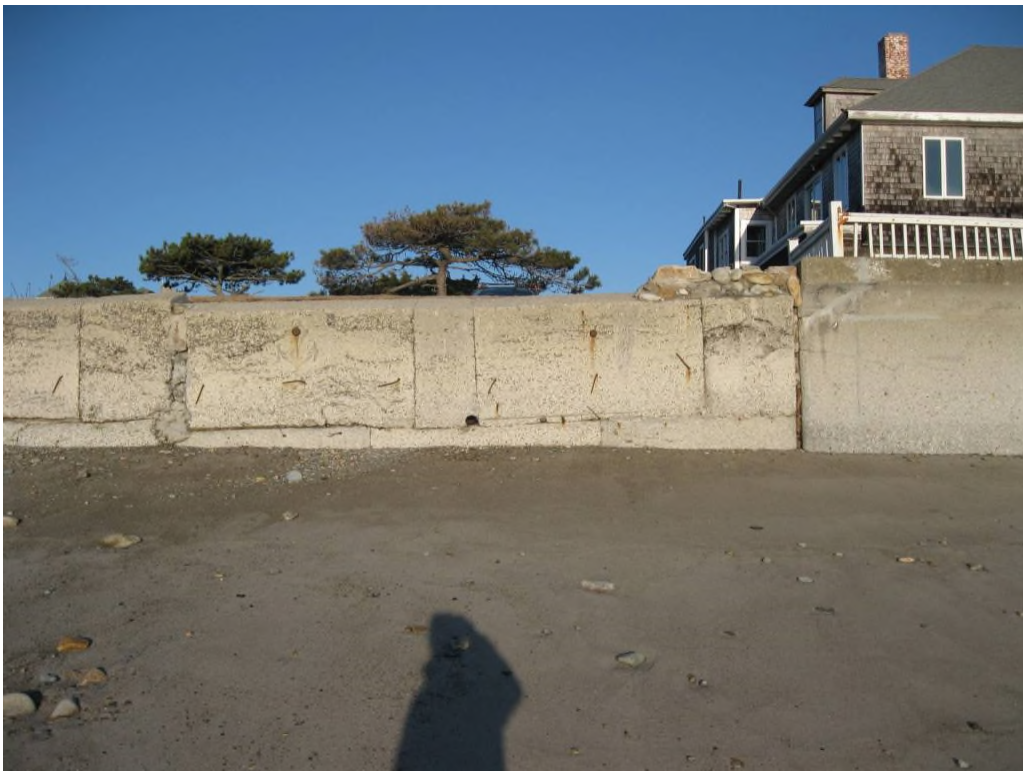
Block wall section

Block Wall	This wall was constructed some time after the other portions of the seawall. This wall is in poor condition and should be replaced at the same time as the adjacent seawall.	1
1	South top corner of section has major cracks; minor & intermediate horizontal and vertical cracks and efflorescence	4
2	Minor & intermediate horizontal and vertical cracks and efflorescence	5
3	Minor & intermediate horizontal and vertical cracks and efflorescence	5
4	Intermediate horizontal and vertical cracks and efflorescence	4
5	Intermediate horizontal and vertical cracks and efflorescence, major vertical and horizontal cracks at north end	3
6	Major horizontal cracks throughout with a couple of vertical cracks; top section of wall broke off & repaired in 2018	2
7	Intermediate & major horizontal cracks throughout; top section of wall broke off & repaired in 2018; revetment in front	2
8	Intermediate vertical cracks, horizontal and vertical cracks and efflorescence; revetment in front	4

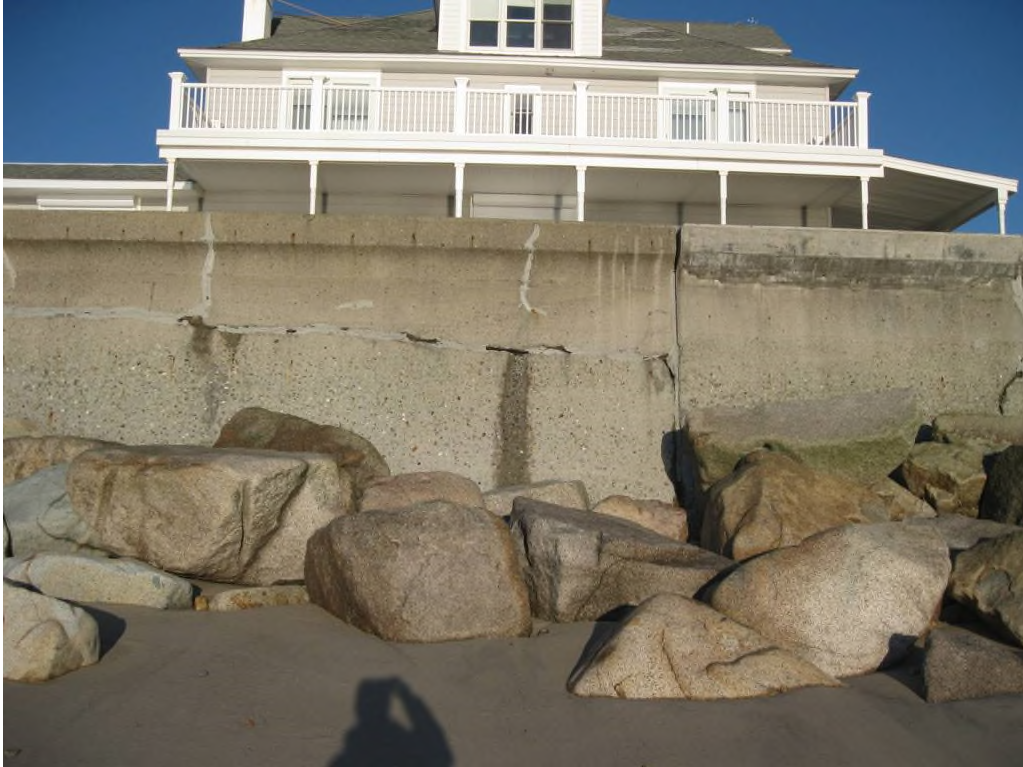
Section 9

9	Major horizontal and vertical cracks throughout; revetment in front	2
10	Major vertical cracks; a portion of the top at south end broke off & repaired in 2018; revetment in front	2
11	Intermediate & major horizontal and vertical cracks throughout; revetment in front	2
12	Intermediate horizontal cracks, major vertical crack about 20 feet from south end; revetment in front	2
13	Minor and intermediate horizontal and vertical cracks; revetment in front	3
14	Minor and intermediate horizontal and vertical cracks; revetment in front	3
15	Minor and intermediate horizontal and vertical cracks; revetment in front	4
16	Minor and intermediate horizontal and vertical cracks; revetment in front	4
17	Minor and intermediate horizontal and vertical cracks, major vertical crack at mid-point; revetment in front	3
18	Minor horizontal and vertical cracks, major vertical crack about 15 feet from north end (section in Marshfield); revetment in front	3
