*Massachusetts Coastal Infrastructure  
Inventory and Assessment Report Update  
Project No. P13-2814-D05 (3841S)*

*Prepared for:  
Massachusetts Department of Conservation and Recreation  
Waterways Division  
Hingham, MA*

**South Shore - South**

**July 2015**

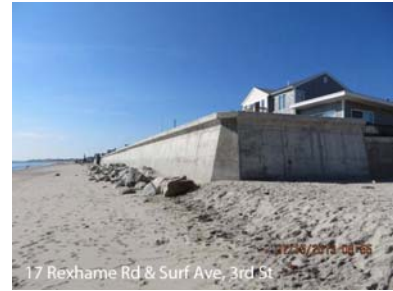
Condition / Ratings / Corrections:  
 Condition / Ratings:  
 Corrections: Upgrade Condition = A (New) for 2000' section from Rexame Road to Old Beach Road

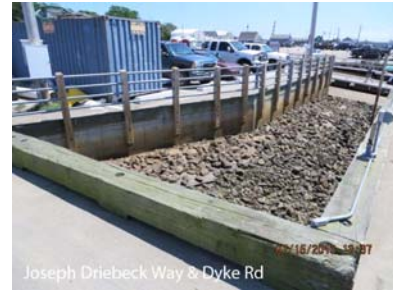
Condition / Ratings / Corrections:  
 Condition / Ratings:  
 Corrections: Revise Length = 125' w/ recent improvements to handrails

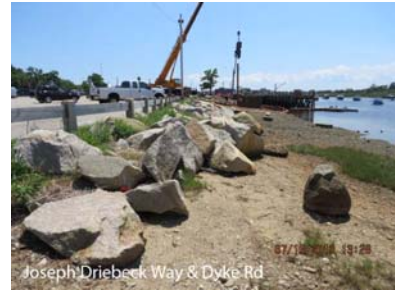
Condition / Ratings / Corrections:  
 Condition / Ratings:  
 Corrections: Reconstruct 200' section of new stone bulkhead

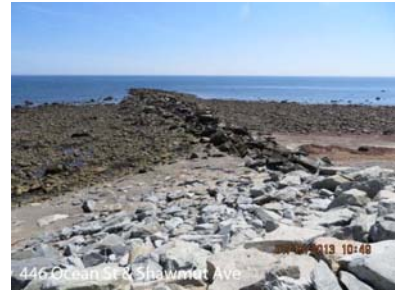
Condition / Ratings / Corrections:  
 Condition / Ratings:  
 Corrections: Downgrade Condition = D (Poor)

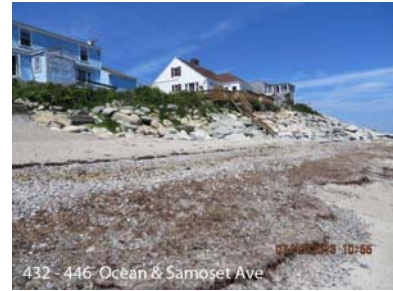
Condition / Ratings / Corrections:  
 Condition / Ratings:  
 Corrections: Downgrade Condition = D (Poor), Increase Priority IV = Residential

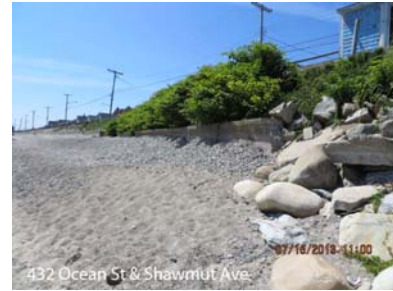
Condition / Ratings / Corrections:  
 Condition / Ratings:  
 Corrections: Downgrade Condition = D (Poor), Increase Priority IV = Roadway & Add Cobble Berm

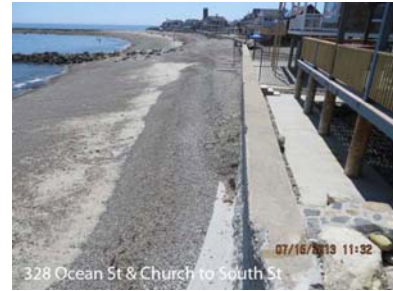
Condition / Ratings / Corrections:  
 Condition / Ratings:  
 Corrections: Downgrade condition of 224' section from North Street to #328 Ocean Street

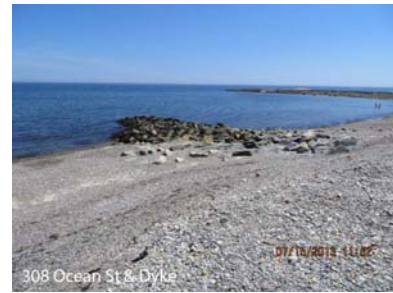
Condition / Ratings / Corrections:  
 Condition / Ratings:  
 Corrections: Downgrade Condition = D (Poor)

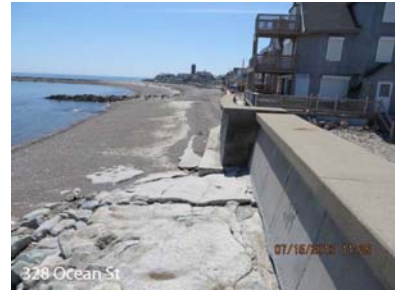
Condition / Ratings / Corrections:  
 Condition / Ratings:  
 Corrections: Downgrade Condition = D due to exposed footing

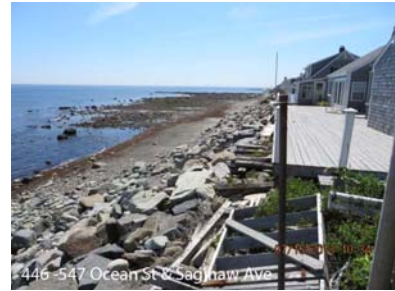
Condition / Ratings / Corrections:  
 Condition / Ratings:  
 Corrections: Downgrade Condition = D (Poor)

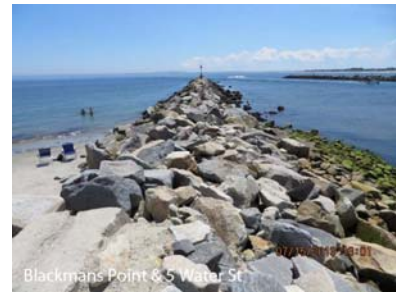
Condition / Ratings / Corrections:  
 Condition / Ratings:  
 Corrections: Increase priority & add Coastal Beach = 254'

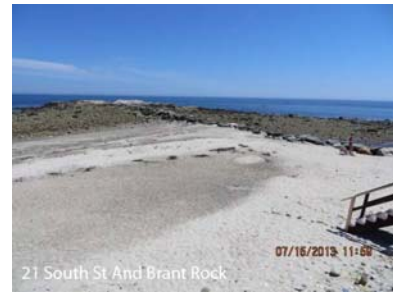
Condition / Ratings / Corrections:  
 Condition / Ratings:  
 Corrections: Downgrade Condition C = Fair

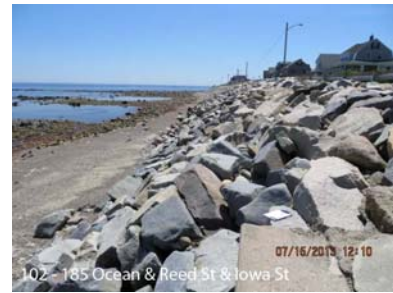
Condition / Ratings / Corrections:  
 Condition / Ratings:  
 Corrections: Downgrade Condition = D (Poor)

Structure Assessment:  
 2013 Assesment: Structure has been downgraded to Condition D (Poor) due to dislodged stones and revetment failures. Priority IV = Okay  
 2006 / 2007 Assesment: This structure is a rubble mound revetment. The armor stone has shifted along much of the structure and some stones are broken. There are no areas of major failure.

<i>Condition</i>	D	<i>Priority</i>	IV
<i>Rating</i>	Poor	<i>Rating</i>	High Priority
<i>Level of Action</i>	Major	<i>Action</i>	Consider for Next Project Construction Listing
<i>Description</i>	See Exhibits I-A for Condition rating description.	<i>Description</i>	See Exhibits I-B for Priority rating description.

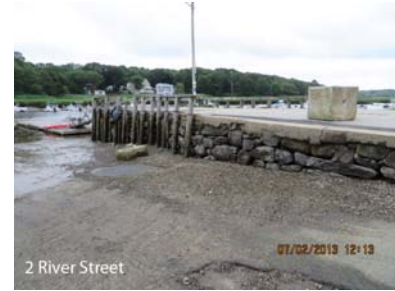
Condition / Ratings / Corrections:  
 Condition / Ratings:  
 Corrections: Downgrade Condition Poor = D & increase priority

<i>Condition</i>	D	<i>Priority</i>	II
<i>Rating</i>	Poor	<i>Rating</i>	Low Priority
<i>Level of Action</i>	Major	<i>Action</i>	Future Project Consideration
<i>Description</i>	See Exhibits I-A for Condition rating description.	<i>Description</i>	See Exhibits I-B for Priority rating description.

Structure Assessment:  
 2013 Assesment: Structure has been downgraded to Condition D (Poor) with failing fender piles, deck cracks, settlement & voids. Town of Kingston plans to replace wharf structure. Priority II= protects town facilities.  
 2006 / 2007 Assesment: Stone block seawall (dryset) with concrete cap which forms filled town wharf. Fender piles around outshore end which appears to be helping retain stones. Many small voids in wall with signs of settling and fill loss inshore.

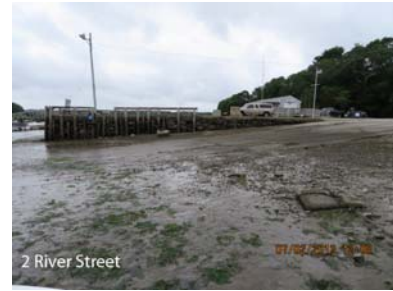
Condition / Ratings / Corrections:  
 Condition / Ratings:  
 Corrections: Downgrade Condition Poor = D, add stone seawall & increase priority

<i>Condition</i>	D	<i>Priority</i>	II
<i>Rating</i>	Poor	<i>Rating</i>	Low Priority
<i>Level of Action</i>	Major	<i>Action</i>	Future Project Consideration
<i>Description</i>	See Exhibits I-A for Condition rating description.	<i>Description</i>	See Exhibits I-B for Priority rating description.

Structure Assessment:  
 2013 Assesment: Ramp structure has been downgraded to Condition D (Poor) with many cracks, spalls and settlement. Stone seawall along parking lot is in Fair Condition = C. No beach on river. Priority II = protects parking lot.  
 2006 / 2007 Assesment: Bituminous concrete boat ramp beside town wharf. Moderate deterioration of pavement.

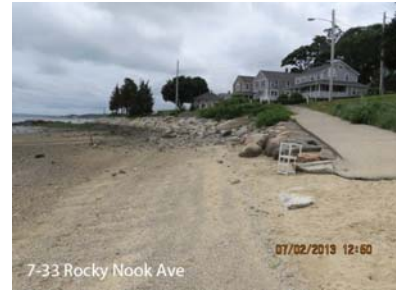
<i>Condition</i>	B	<i>Priority</i>	III
<i>Rating</i>	Good	<i>Rating</i>	Moderate Priority
<i>Level of Action</i>	Minor	<i>Action</i>	Consider for Active Project Improvement Listing
<i>Description</i>	See Exhibits I-A for Condition rating description.

Structure Assessment:  
 2013 Assesment: No change in Condition of structure, with some minor settlement & deformation & erosion at top revetment & rip-rap. Priority III = Okay  
 2006 / 2007 Assesment: Erosion rip rap slope (1 vertical to 2 horizontal) with 1 to 2 ton stones. Toed into sandy beach outshore (just below mean low water). Erosion evident above top of wall (stones dumped along top). Road inshore of slope.

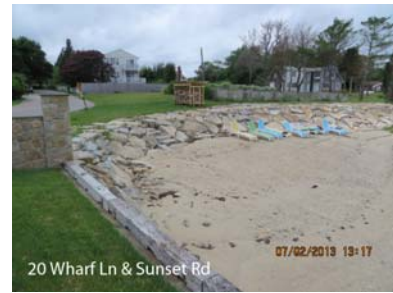
Condition / Ratings / Corrections:  
 Condition / Ratings:  
 Corrections: Downgrade Condition Poor = D, revise length = 215' (both sides)

<i>Condition</i>	D	<i>Priority</i>	III
<i>Rating</i>	Poor	<i>Rating</i>	Moderate Priority
<i>Level of Action</i>	Major	<i>Action</i>	Consider for Active Project Improvement
<i>Description</i>	See Exhibits I-A for Condition rating description.		Listing

Structure Assessment:  
 2013 Assesment: Structure has been downgraded to Condition D (Poor) with displaced & deforming rip-rap with top of bank erosion & pavement damage. Priority III = Okay  
 2006 / 2007 Assesment: Placed rip rap slope (1 vertical to 2 horizontal) toed into sandy beach. 500 to 2000 lb. stone with chinking done well.

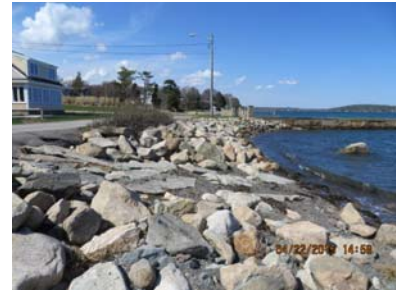
<i>Condition</i>	B	<i>Priority</i>	II
<i>Rating</i>	Good	<i>Rating</i>	Low Priority
<i>Level of Action</i>	Minor	<i>Action</i>	Future Project Consideration
<i>Description</i>	See Exhibits I-A for Condition rating description.	<i>Description</i>	See Exhibits I-B for Priority rating description.

Structure Assessment:  
 2013 Assesment: Revetment in Good to Fair condition with minor erosion at top of slope. Carry down boat access built into revetment.  
 2006 / 2007 Assesment:

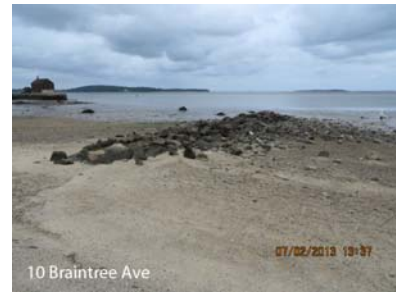
Condition / Ratings / Corrections:  
 Condition / Ratings:  
 Corrections: Revise Length 120', Downgrade Condition Poor = D, Add Beach = 400'

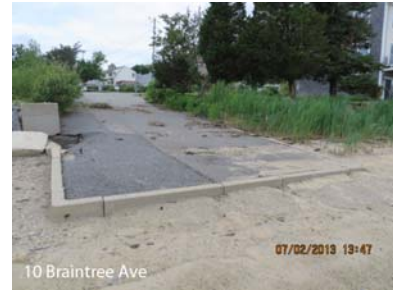
Condition / Ratings / Corrections:  
 Condition / Ratings:  
 Corrections: Downgrade Condition Poor = D & Increase Priority II

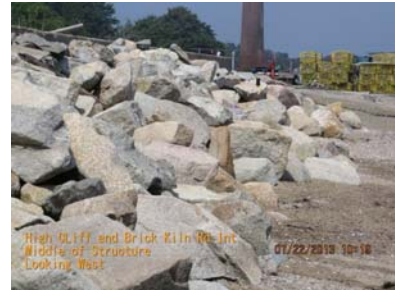
<i>Condition</i>	C	<i>Priority</i>	III
<i>Rating</i>	Fair	<i>Rating</i>	Moderate Priority
<i>Level of Action</i>	Moderate	<i>Action</i>	Consider for Active Project Improvement
<i>Description</i>	See Exhibits I-A for Condition rating description.		Listing

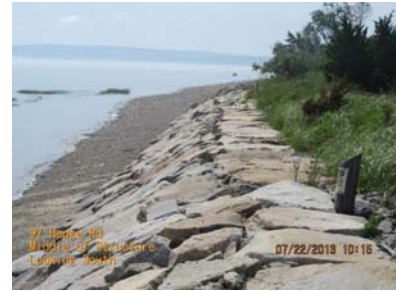
<i>Condition</i>	B	<i>Priority</i>	III
<i>Rating</i>	Good	<i>Rating</i>	Moderate Priority
<i>Level of Action</i>	Minor	<i>Action</i>	Consider for Active Project Improvement Listing
<i>Description</i>	See Exhibits I-A for Condition rating description.

Structure Assessment:  
 2013 Assesment: No change.  
 2006 / 2007 Assesment: This structure is a stone revetment. The side slopes and crest are in excellent condition. There is minor and isolated cracking and displacement of some armor stones.

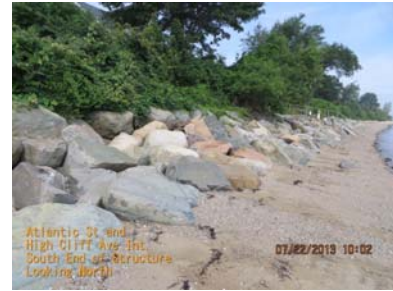
<i>Condition</i>	C	<i>Priority</i>	IV
<i>Rating</i>	Fair	<i>Rating</i>	High Priority
<i>Level of Action</i>	Moderate	<i>Action</i>	Consider for Next Project Construction Listing
<i>Description</i>	See Exhibits I-A for Condition rating description.	<i>Description</i>	See Exhibits I-B for Priority rating description.

Structure Assessment:  
 2013 Assesment: No change.  
 2006 / 2007 Assesment: This structure is a stone revetment. There are shifted armor stone and slumping of the side slopes evident, conditions worsens towards the south end of the structure.

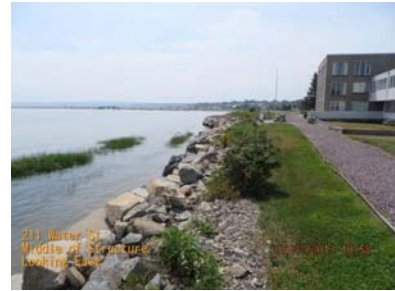
<i>Condition</i>	C	<i>Priority</i>	IV
<i>Rating</i>	Fair	<i>Rating</i>	High Priority
<i>Level of Action</i>	Moderate	<i>Action</i>	Consider for Next Project Construction Listing
<i>Description</i>	See Exhibits I-A for Condition rating description.	<i>Description</i>	See Exhibits I-B for Priority rating description.

Structure Assessment:  
 2013 Assesment: Placed rip rap stone revetment that is grouted at the northern corner with very steep side slopes. The grouted area has minor cracking. The majority of the structure has moderate movement with many stones displaced with minor to moderate erosion behind.  
 2006 / 2007 Assesment: This structure is a stone revetment. The side slopes are very steep and also vertical in some sections. The northern corner is grouted. There are many areas of shifted and displaced armor stones. The oversteepened side slopes are a stability concern.

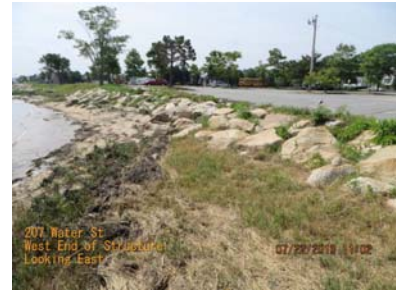
<i>Condition</i>	C	<i>Priority</i>	II
<i>Rating</i>	Fair	<i>Rating</i>	Low Priority
<i>Level of Action</i>	Moderate	<i>Action</i>	Future Project Consideration
<i>Description</i>	See Exhibits I-A for Condition rating description.	<i>Description</i>	See Exhibits I-B for Priority rating description.

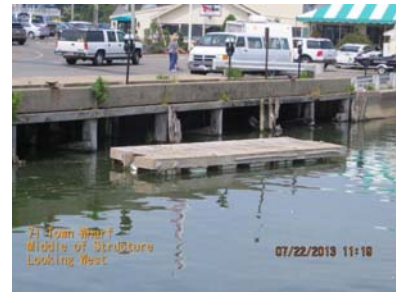
<i>Condition</i>	C	<i>Priority</i>	III
<i>Rating</i>	Fair	<i>Rating</i>	Moderate Priority
<i>Level of Action</i>	Moderate	<i>Action</i>	Consider for Active Project Improvement Listing
<i>Description</i>	See Exhibits I-A for Condition rating description.

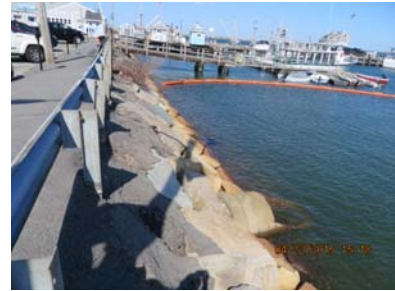
<i>Condition</i>	B	<i>Priority</i>	II
<i>Rating</i>	Good	<i>Rating</i>	Low Priority
<i>Level of Action</i>	Minor	<i>Action</i>	Future Project Consideration
<i>Description</i>	See Exhibits I-A for Condition rating description.	<i>Description</i>	See Exhibits I-B for Priority rating description.

Structure Assessment:  
 2013 Assesment: Stone revetment in good condition. Supports side walk and street parking.  
 2006 / 2007 Assesment:

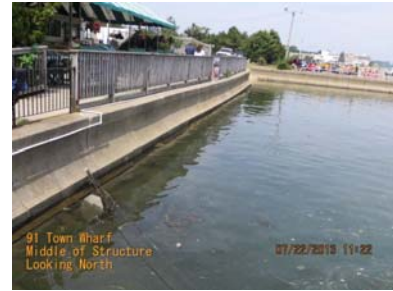
<i>Condition</i>	C	<i>Priority</i>	IV
<i>Rating</i>	Fair	<i>Rating</i>	High Priority
<i>Level of Action</i>	Moderate	<i>Action</i>	Consider for Next Project Construction Listing
<i>Description</i>	See Exhibits I-A for Condition rating description.	<i>Description</i>	See Exhibits I-B for Priority rating description.

2013 Assesment: Placed rip rap revetment with a cast in place footing on top supporting a precast with a wave return face. The precast concrete has moderate cracking and scaling of the concrete and has shifted and moved. The rip rap stones have shifted and settled creating voids under the footing. The toe was buried and minor scour. The footing has deteriorated with cracking and missing in locations where undermined.

2006 / 2007 Assesment: This structure is a stone revetment with a wave return face concrete cap. The cap is weathered and shows some spalling. Certain sections appear tilted forward somewhat. The stone sideslopes have slumped in some sections, appearing to create a gap

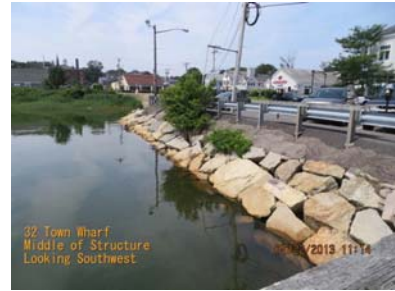
<i>Condition</i>	B	<i>Priority</i>	III
<i>Rating</i>	Good	<i>Rating</i>	Moderate Priority
<i>Level of Action</i>	Minor	<i>Action</i>	Consider for Active Project Improvement Listing
<i>Description</i>	See Exhibits I-A for Condition rating description.

Structure Assessment:  
 2013 Assesment: Placed stone rip rap revetment with asphalt at the top. There is minor movement and settlement of stones. The toe of the structure is buried.  
 2006 / 2007 Assesment: This structure is a stone revetment. The sideslopes show some weathering but are generally in good condition.

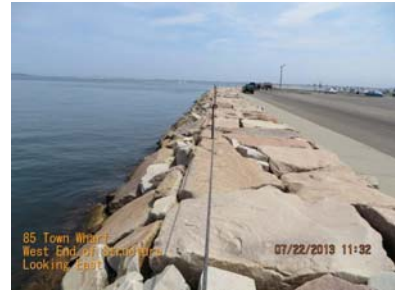
<i>Condition</i>	B	<i>Priority</i>	IV
<i>Rating</i>	Good	<i>Rating</i>	High Priority
<i>Level of Action</i>	Minor	<i>Action</i>	Consider for Next Project Construction Listing
<i>Description</i>	See Exhibits I-A for Condition rating description.	<i>Description</i>	See Exhibits I-B for Priority rating description.

Structure Assessment:  
 2013 Assesment: Placed rip rap stone revetment. There is minor movement of the stones with a few stones cracked. The toe of the revetment was buried.  
 2006 / 2007 Assesment: This structure is a stone revetment along the northwest corner of Plymouth Harbor Town boat ramp parking lot. The side slopes and crest are in good condition. The armor stone shows minor weathering.

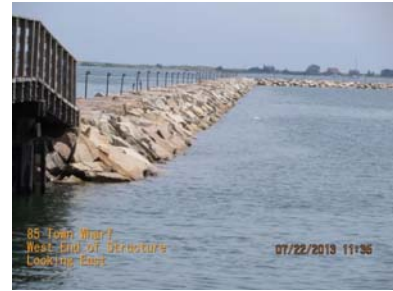
<i>Condition</i>	C	<i>Priority</i>	IV
<i>Rating</i>	Fair	<i>Rating</i>	High Priority
<i>Level of Action</i>	Moderate	<i>Action</i>	Consider for Next Project Construction Listing
<i>Description</i>	See Exhibits I-A for Condition rating description.	<i>Description</i>	See Exhibits I-B for Priority rating description.

Structure Assessment:  
 2013 Assesment: Placed rip rap stone revetment breakwater. There is minor movement of the stones with a few stones cracked, settled, and displaced. The toe of the breakwater was underwater at the time of inspection.  
 2006 / 2007 Assesment: This structure is a rubble mound breakwater around the northern side of Plymouth Harbor. There is a scour apron along the inside and outside toe for the outer 175 yards of the structure. Overall the crest and sideslopes appear in good condition. Howev

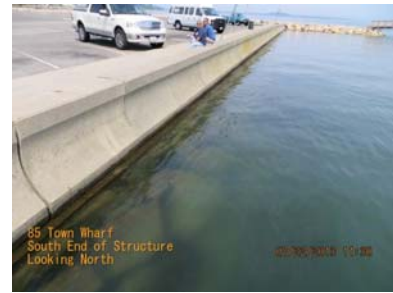
<i>Condition</i>	B	<i>Priority</i>	III
<i>Rating</i>	Good	<i>Rating</i>	Moderate Priority
<i>Level of Action</i>	Minor	<i>Action</i>	Consider for Active Project Improvement Listing
<i>Description</i>	See Exhibits I-A for Condition rating description.

Structure Assessment:  
 2013 Assesment: Placed rip rap revetment with a cast in place footing on top supporting a precast with a wave return face. The precast concrete has minor cracking and scaling of the concrete and has shifted and moved slightly. The rip rap stones have minor to moderate shifting and settling of the stones. The toe was buried. The footing has minor cracking and scaling.  
 2006 / 2007 Assesment: This structure is a stone revetment topped with wave return face concrete sections. The concrete cap shows minor cracking. The stone side slopes are in good condition and the stone itself shows some weathering.

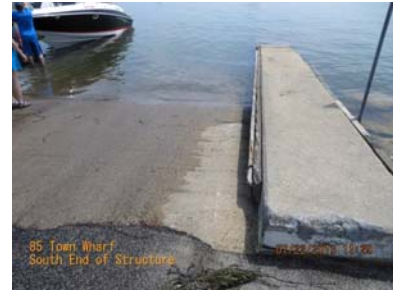
<i>Condition</i>	B	<i>Priority</i>	III
<i>Rating</i>	Good	<i>Rating</i>	Moderate Priority
<i>Level of Action</i>	Minor	<i>Action</i>	Consider for Active Project Improvement
<i>Description</i>	See Exhibits I-A for Condition rating description.		Listing

Structure Assessment:  
 2013 Assesment: No change.  
 2006 / 2007 Assesment: This structure is a concrete boat ramp for the town. There is some cracking along the surface of the ramp. It is generally in good condition.

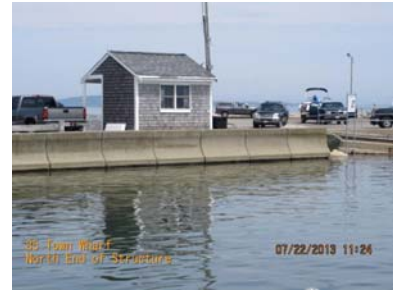
<i>Condition</i>	B	<i>Priority</i>	III
<i>Rating</i>	Good	<i>Rating</i>	Moderate Priority
<i>Level of Action</i>	Minor	<i>Action</i>	Consider for Active Project Improvement Listing
<i>Description</i>	See Exhibits I-A for Condition rating description.

Structure Assessment:  
 2013 Assesment: No change.  
 2006 / 2007 Assesment: This structure is a stone revetment with a wave return face concrete cap. The concrete cap shows spalling and discoloration. The stone is weathered but in good condition. The side slopes remain entirely intact.

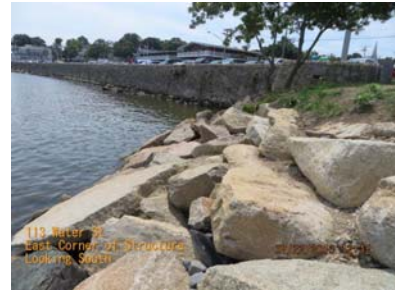
<i>Condition</i>	C	<i>Priority</i>	III
<i>Rating</i>	Fair	<i>Rating</i>	Moderate Priority
<i>Level of Action</i>	Moderate	<i>Action</i>	Consider for Active Project Improvement
<i>Description</i>	See Exhibits I-A for Condition rating description.		Listing

Structure Assessment:  
 2013 Assesment: Dumped rip rap stone revetment that is mortared for the bottom half. The top has moderate movement and settlement of the stones and are not well connected. There is moderate erosion at the top due to settlement and additional stones have been added. The mortar on the bottom is cracking and loose with the stones have shifted.  
 2006 / 2007 Assesment: This structure is a stone revetment fronting a small park. The bottom half of the armor stone is grouted. The top and bottom sections are not well connected, with the top being slumped in sections.

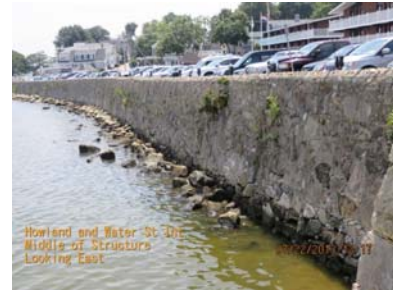
<i>Condition</i>	C	<i>Priority</i>	III
<i>Rating</i>	Fair	<i>Rating</i>	Moderate Priority
<i>Level of Action</i>	Moderate	<i>Action</i>	Consider for Active Project Improvement
<i>Description</i>	See Exhibits I-A for Condition rating description.		Listing

Structure Assessment:  
 2013 Assesment: Mortared stone seawall with rip rap along the toe. The stone along the toe has moderate movement, settlement, and displaced providing little protection at the base. The bottom of the wall the mortar is loose or missing.  
 2006 / 2007 Assesment: This structure is a grouted stone seawall with rip rap along the toe. The stone along the toe is slumped and unraveled to the point where it no longer protects the base of the wall. The base of the wall shows some missing grout between stones and other

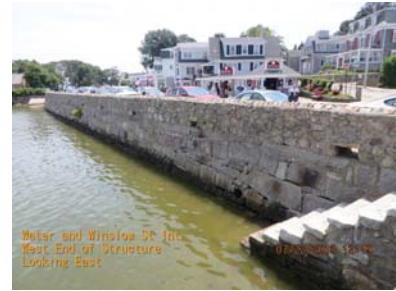
<i>Condition</i>	C	<i>Priority</i>	III
<i>Rating</i>	Fair	<i>Rating</i>	Moderate Priority
<i>Level of Action</i>	Moderate	<i>Action</i>	Consider for Active Project Improvement
<i>Description</i>	See Exhibits I-A for Condition rating description.		Listing

Structure Assessment:  
 2013 Assesment: No change.  
 2006 / 2007 Assesment: This structure is a seawall of grouted stone. The stone is stacked at the bottom and has a cap of random placed grouted stone. There is grout missing and/or broken along the base of the wall.

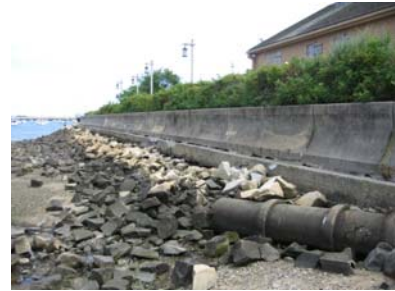
<i>Condition</i>	D	<i>Priority</i>	III
<i>Rating</i>	Poor	<i>Rating</i>	Moderate Priority
<i>Level of Action</i>	Major	<i>Action</i>	Consider for Active Project Improvement Listing
<i>Description</i>	See Exhibits I-A for Condition rating description.

Structure Assessment:  
 2013 Assesment: No change.  
 2006 / 2007 Assesment: This structure is a short concrete seawall with a wave return face cap and small armor stone strewn along the base. The wall shows severe cracking and spalling along the face. The northern end is slumped.

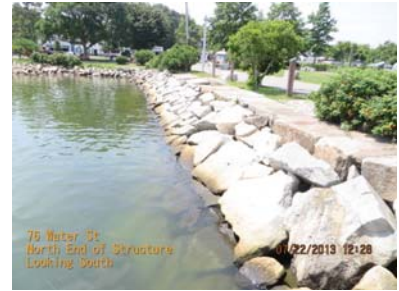
<i>Condition</i>	C	<i>Priority</i>	III
<i>Rating</i>	Fair	<i>Rating</i>	Moderate Priority
<i>Level of Action</i>	Moderate	<i>Action</i>	Consider for Active Project Improvement Listing
<i>Description</i>	See Exhibits I-A for Condition rating description.

Structure Assessment:  
 2013 Assesment: Dumped stone rip rap revetment. There is minor to moderate movement and settlement of the stones. There are locations where the crest is slumped and there is cracking of the armor stones. There was no undermining visible at the time of inspection.  
 2006 / 2007 Assesment:

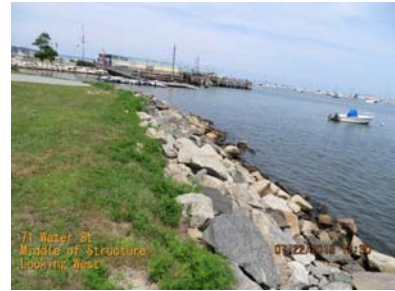
<i>Condition</i>	C	<i>Priority</i>	III
<i>Rating</i>	Fair	<i>Rating</i>	Moderate Priority
<i>Level of Action</i>	Moderate	<i>Action</i>	Consider for Active Project Improvement
<i>Description</i>	See Exhibits I-A for Condition rating description.		Listing

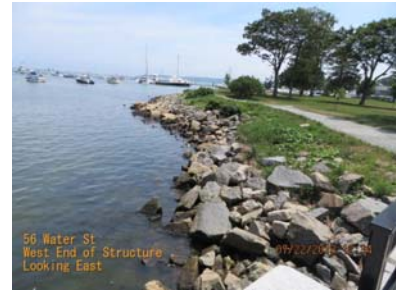
<i>Condition</i>	C	<i>Priority</i>	III
<i>Rating</i>	Fair	<i>Rating</i>	Moderate Priority
<i>Level of Action</i>	Moderate	<i>Action</i>	Consider for Active Project Improvement
<i>Description</i>	See Exhibits I-A for Condition rating description.		Listing

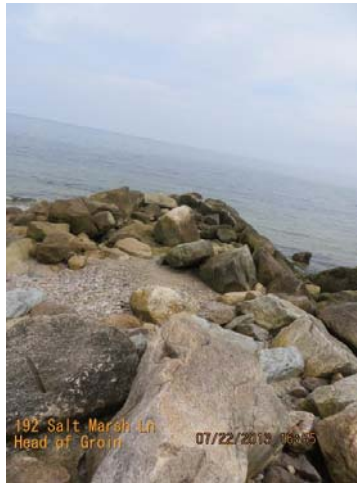
192 Salt Marsh Ln  
Head of Groin 07/22/2019 08:55  
057-053-021-059-100-PHO13B.jpg
