Duxbury Seawalls **Condition Survey and Study** *Duxbury, MA*

Project No. P10-2606-G2, (3779-G)

July 2012

Prepared By:
Bourne Consulting Engineering
3 Bent Street
Franklin, MA 02038

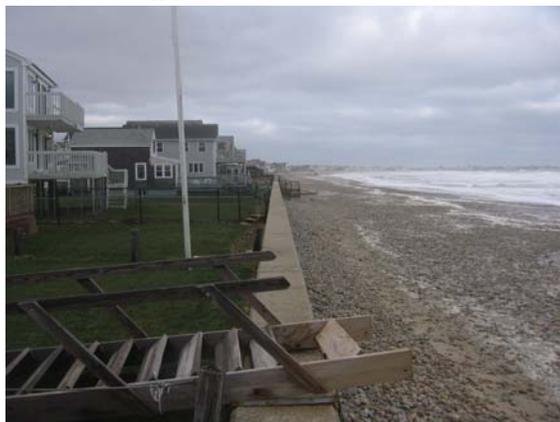
Typical condition STA 100+00 – 110+50

- Many houses are on raised foundations above grade.
- Decks are typically elevated on sono-tube foundations and close to back of wall.
- Existing grade behind is below top of wall.
- Minimum house set-back is 18’
- Maximum house set-back is 95’
- Typical house set-back is 30’-40’

- Raised foundations and grade sloping away behind wall will reduce impact of flood water over wall
- Close proximity of houses to wall increase potential impacts of structural damage
- Desirable overtopping limit should be based on minimizing potential for structural damage – Proposed limit 0.0003 ft³/sec/ft.

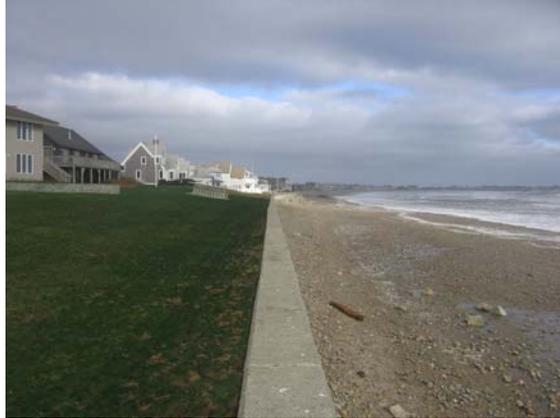
Typical condition STA 110+50 – 115+50

- Houses are on grade and grade is raised behind wall.
- Area behind wall is grass.
- Typical house set-back is 95'
- Typical house set-back is 30'-40'

- Large setback and upward grade will reduce impact of flood water over wall
- Large setback will reduce potential impacts of structural damage
- Desirable overtopping limit should be based on minimizing erosion of grassed areas – Proposed limit $0.02 \text{ ft}^3/\text{sec}/\text{ft}$.

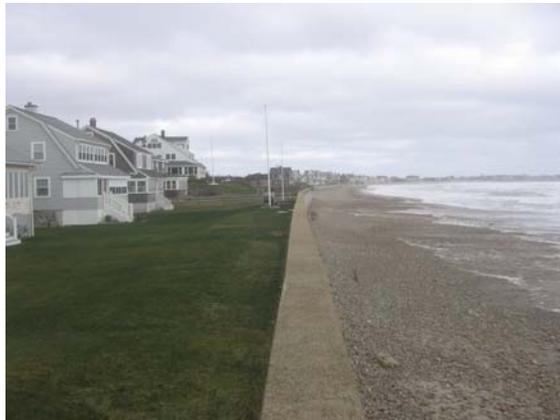
Typical condition STA 115+50 – 117+00

- Many houses are on raised foundation.
- Grade is typically below top of wall and slopes away to Gurnet Road behind.
- Decks are typically elevated on sono-tube foundations
- Minimum house set-back is 26'
- Typical house set-back is 40'-50'

- Significant setback and sloping grade will reduce impact of flood water over wall
- Significant setback will reduce potential impacts of structural damage
- Flow towards houses potentially affects occupants outside
- Desirable overtopping limit should be based on pedestrian safety – Proposed limit $0.003 \text{ ft}^3/\text{sec}/\text{ft}$.

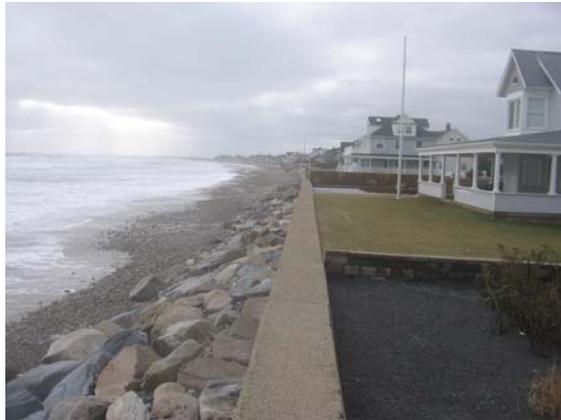
Typical condition STA 200+00 – 208+00

- Houses are typically on grade along this stretch of wall.
- Decks are raised and attached to the houses.
- Minimum house set-back is 18'
- Maximum house set-back is 53'
- Typical house set-back is 20'-30'

- Grade sloping away behind wall will reduce impact of flood water over wall
- Construction on grade increases potential flood impact
- Significant setback will reduce potential impacts of structural damage
- Flow towards houses potentially affects occupants outside
- Desirable overtopping limit should be based on pedestrian safety – Proposed limit 0.003 ft³/sec/ft

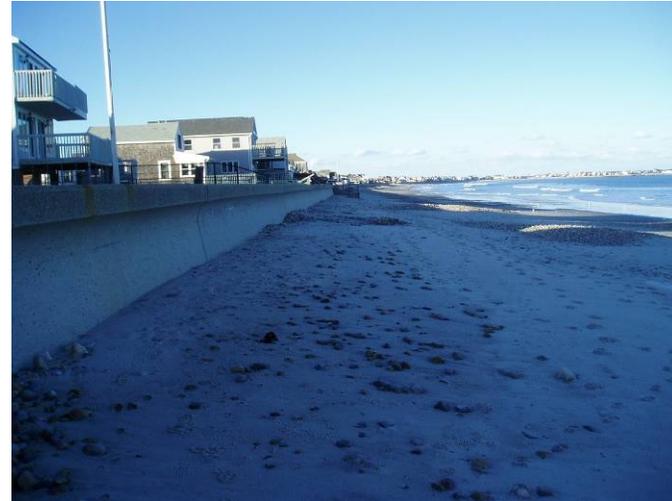
PHOTOGRAPH 7 - BEACH AFTER ACCRETION

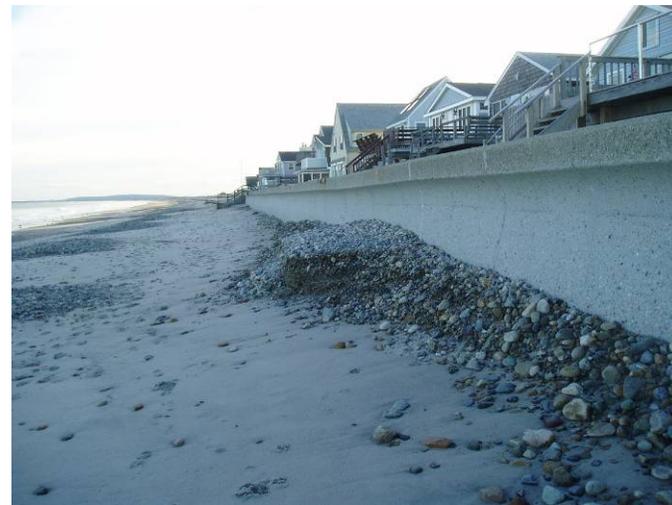
PHOTOGRAPH 8 - FROZEN COBBLE AGAINST WALL

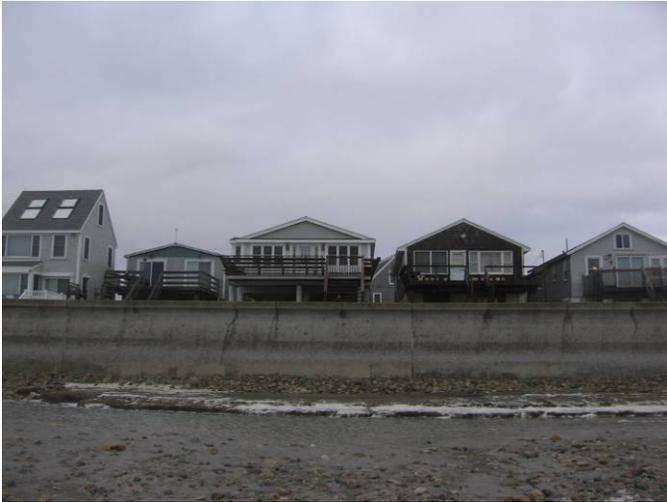
PHOTOGRAPH 9 - WALL ELEVATION STA 107+00 ERODED BEACH

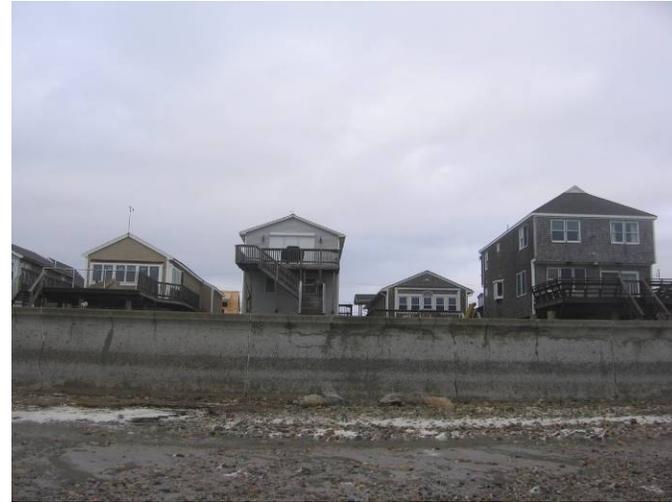
PHOTOGRAPH 11 - WALL ELEVATION STA 109+00 ERODED BEACH

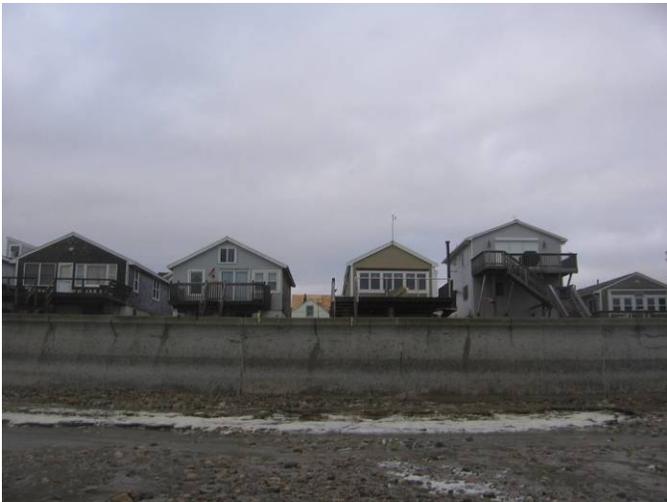
PHOTOGRAPH 10 - WALL ELEVATION STA 108+00 ERODED BEACH

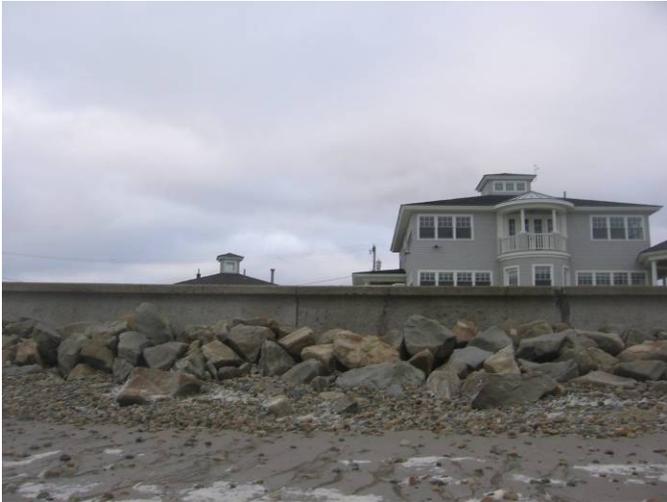
PHOTOGRAPH 13 - RIP RAP AT WALL "BOW" STA 118+00
ERODED BEACH

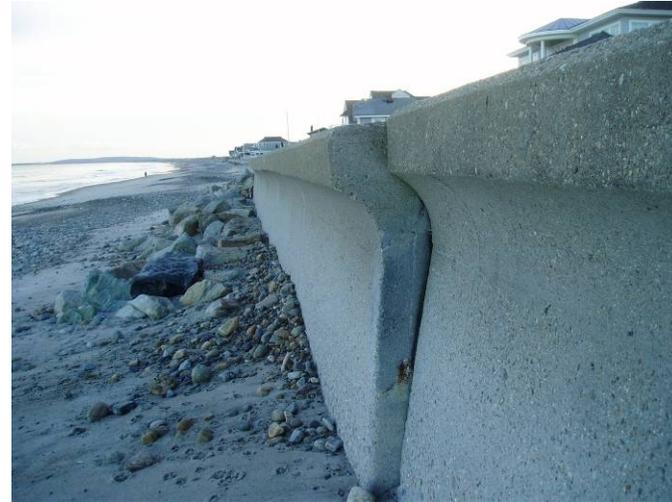
PHOTOGRAPH 15 - ROTATION IN WALL ~ 119+75 ±

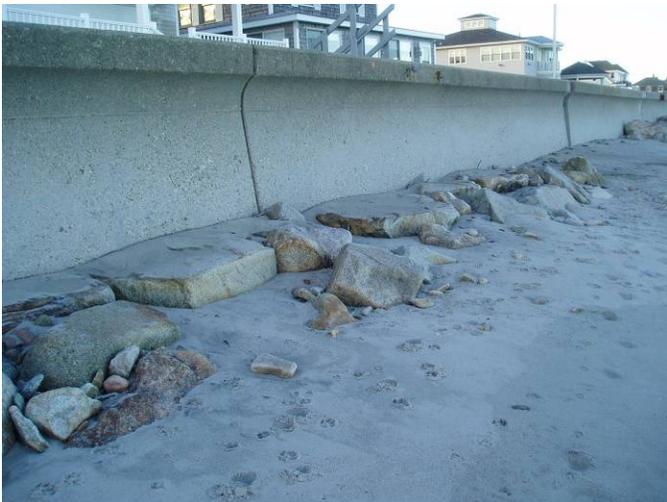
PHOTOGRAPH 14 - BEACH AT STA 116+00 AFTER ACCRETION

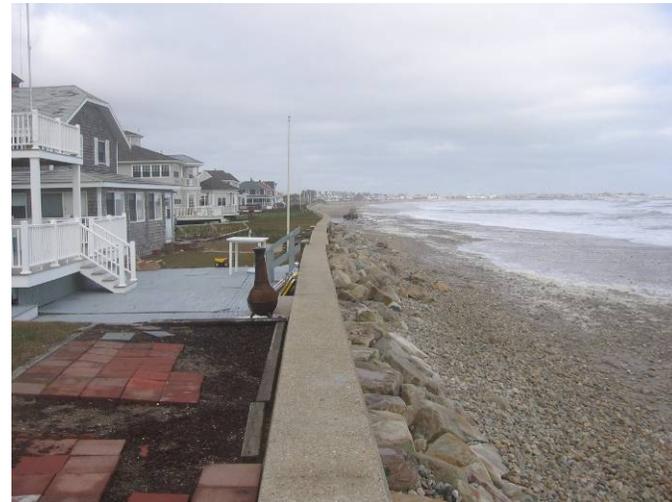
PHOTOGRAPH 16 - WALL CURVATURE STA 117+00 - 120+00

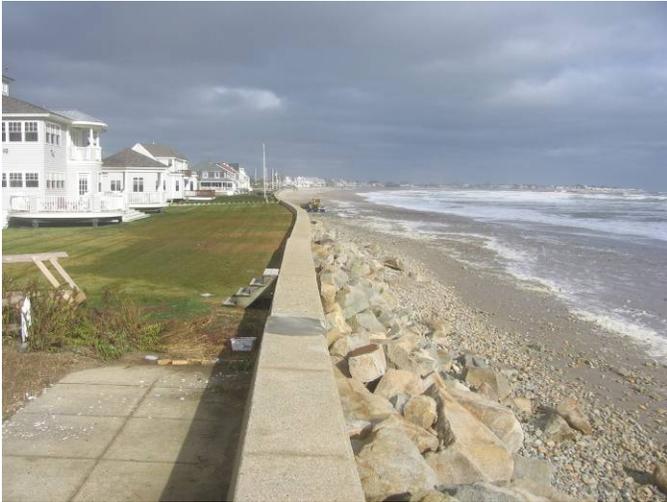
PHOTOGRAPH 17 - WALL CURVATURE AND DEAD GRASS BEHIND (OVER TOPPING)

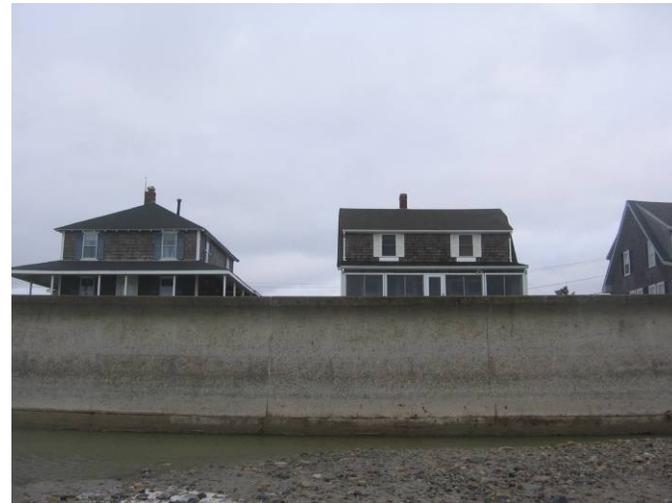
PHOTOGRAPH 20 - AREA WAS "REPAIRED" BY TOWN WITH BUCKET LOADER- MOVED SAND IN FRONT OF WALL ON 11/11/10

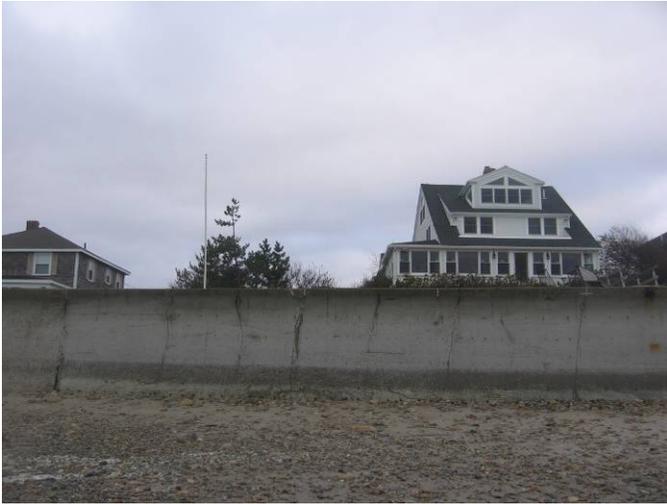
PHOTOGRAPH 21 - CHANGE IN WALL CONSTRUCTION APPROX. STA 127+00.

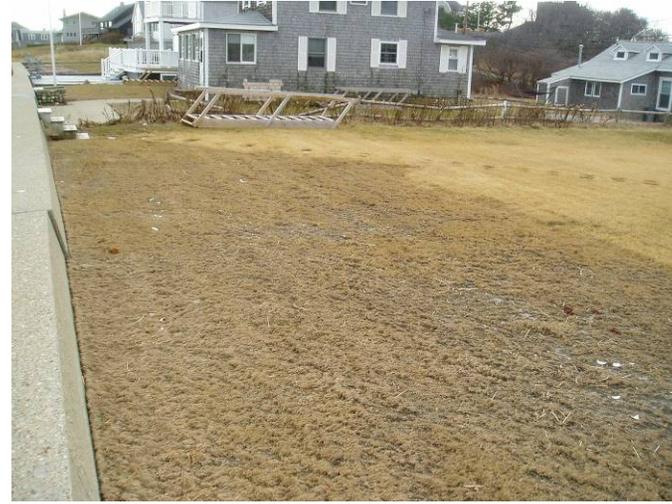
PHOTOGRAPH 27 - DEAD GRASS

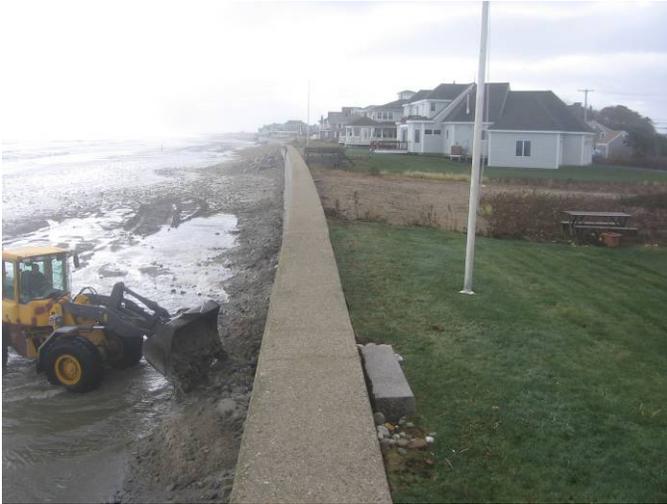
PHOTOGRAPH 29 - BACK LOADER FILLING IN FRONT OF WALL AT UNDERMINING

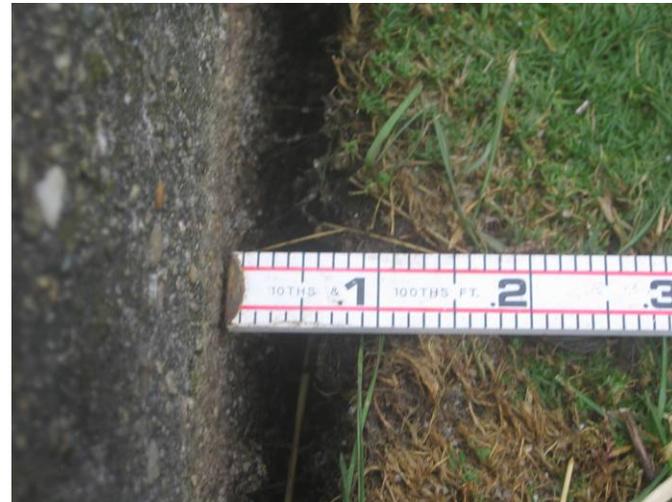
PHOTOGRAPH 32 - MOVEMENT OF WALL OUT SHORE

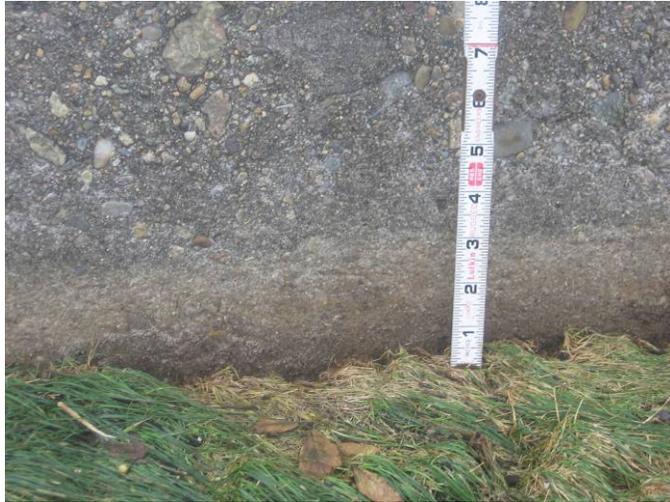
PHOTOGRAPH 33 - SETTLEMENT BEHIND WALL

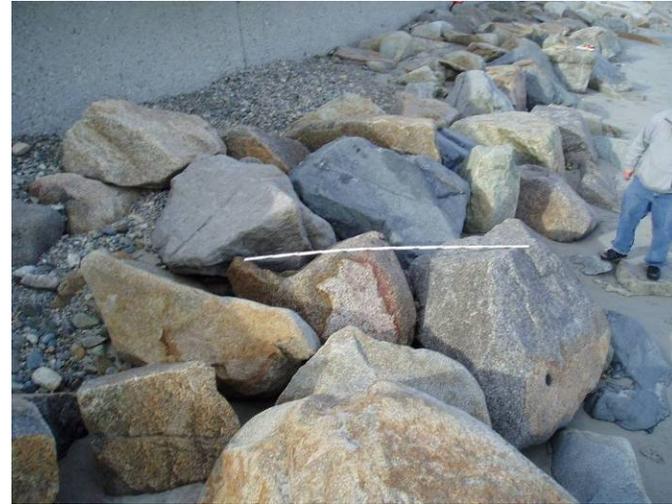
PHOTOGRAPH 43 - TYPICAL RIP RAP CONDITION

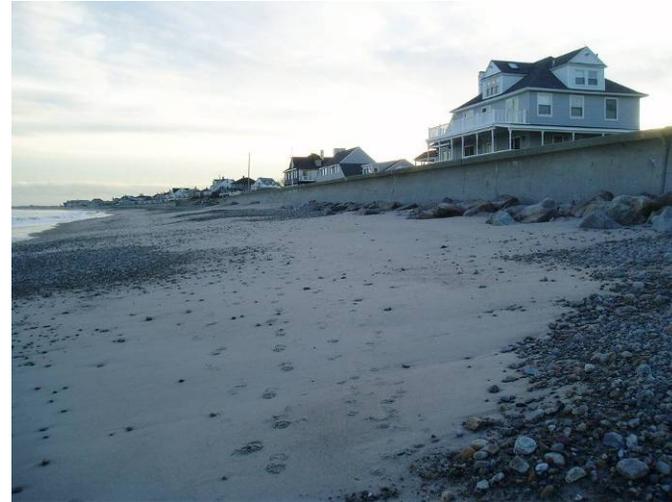
PHOTOGRAPH 47 - TYPICAL BEACH CONDITION NORTH WALL

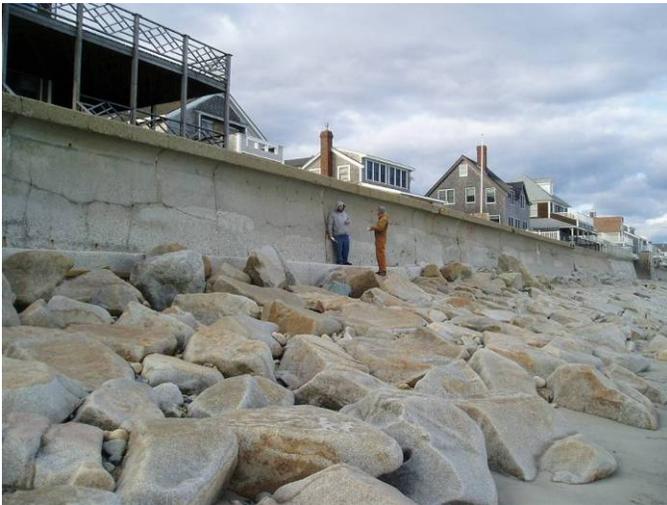
PHOTOGRAPH 52 - WALL W/ RIP RAP STA 210+00

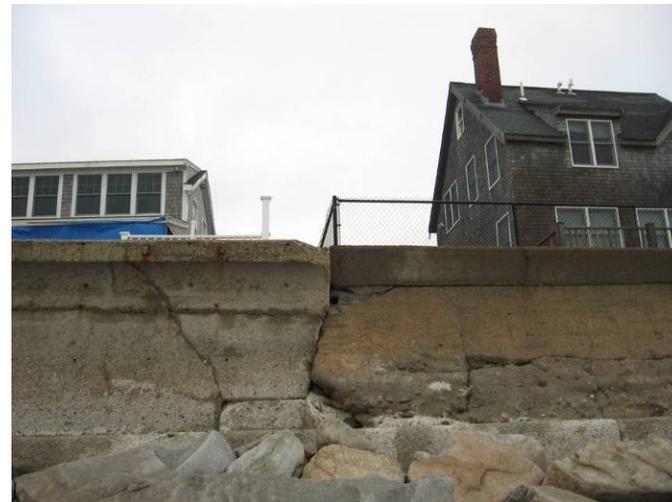
PHOTOGRAPH 54 - CHANGE IN CONSTRUCTION

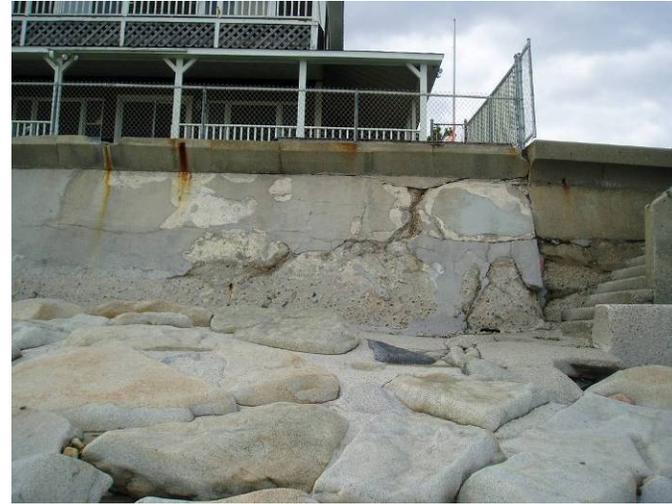
PHOTOGRAPH 57 - CONC. BETWEEN STONES

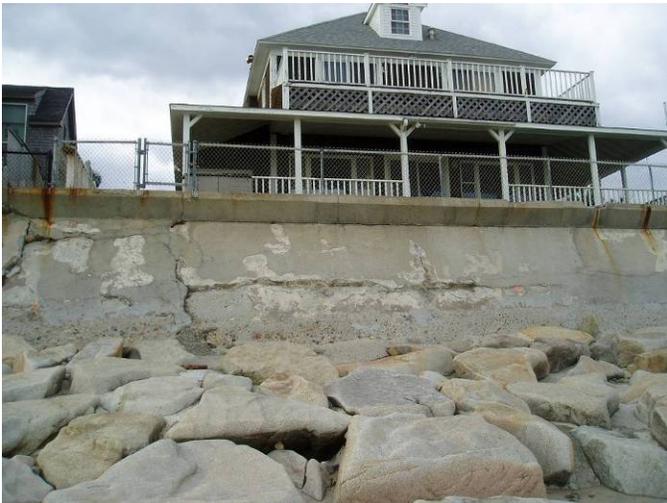
PHOTOGRAPH 56 - ROUNDED WEATHERED ROCKS

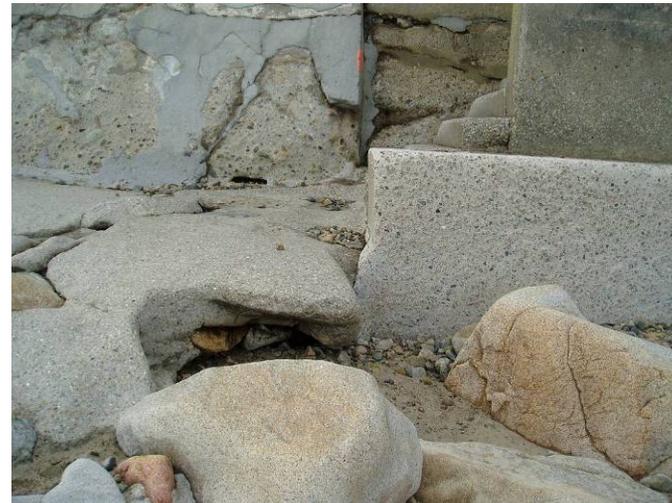
PHOTOGRAPH 58 - UNDERCUTTING
